HISTORIC PRESERVATION ASSISTANCE PROJECT

Strafford Rockingham Regional Council

| COMMON NAME: The Mahone House | | FUNCTIONAL TYPE: Dwelling |
| HISTORIC NAME: John Goodwin House | | PRESENT USE: Residential |

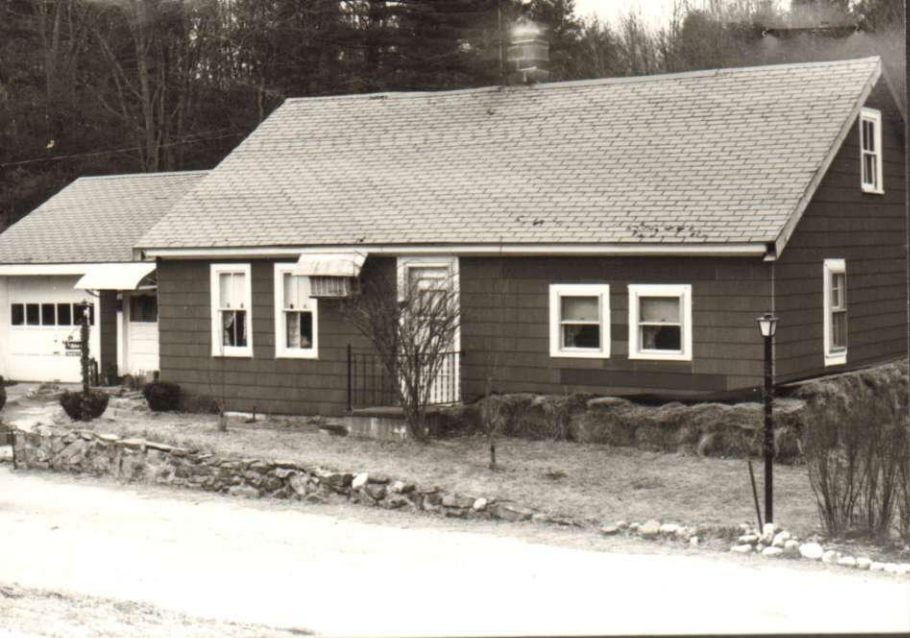
Front (F) Side (N)
