HISTORIC PRESERVATION ASSISTANCE PROJECT

Strafford Rockingham Regional Council

TOWN: Kingston	COUNTY: Rockingham
SURVEY NUMBER: 5*	
COMMON NAME: Kingston House	
HISTORIC NAME: Robie House	
LOCATION: East side of Main St., .14 miles N of inter. of Main and W. Main.	
OWNER: Main St. & Scotland Realty, Inc.	
ADDRESS: 1 Scotland Kingston, NH.	
MAP & PARCEL #: U-8/131	
DATE: c. 1750	
SOURCE: Inspection	
STYLE: Georgian

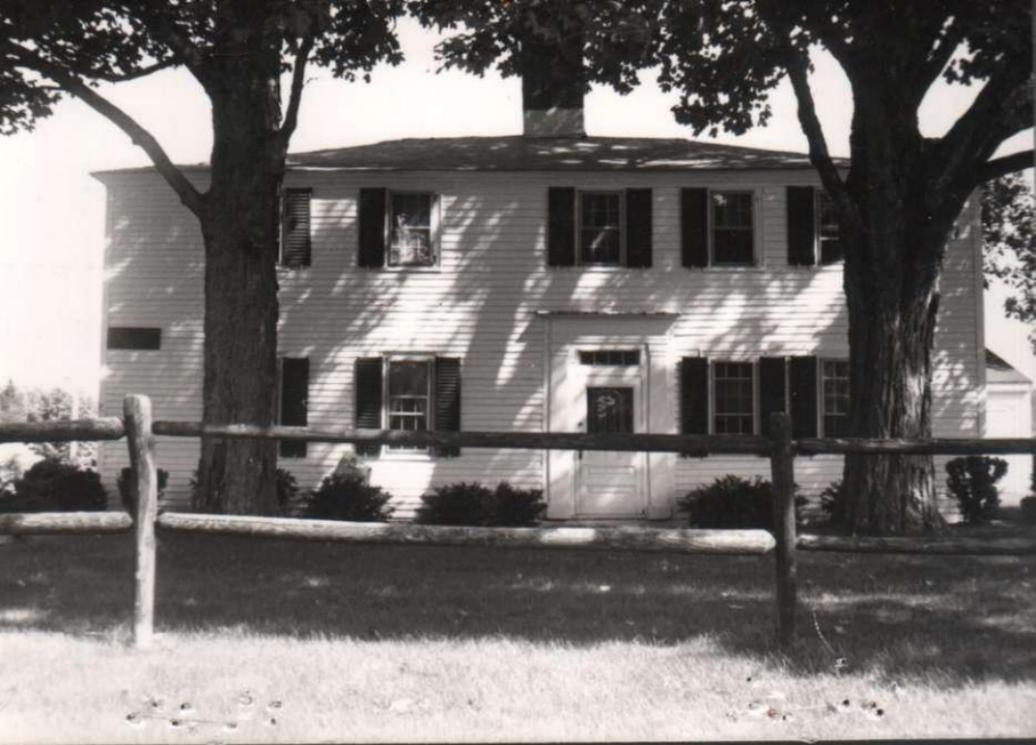
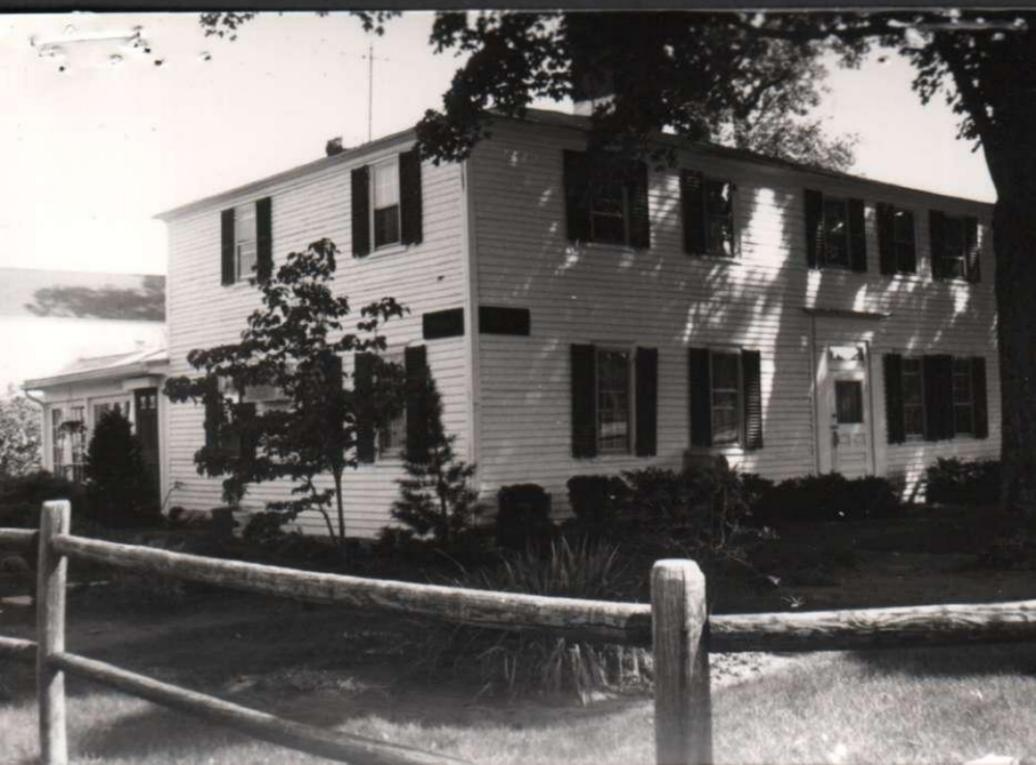
PHOTO

Description of View: Front-west
Side-north

The Speliotis House is a 2-story, hip-roofed, central chimney Georgian style house. The center entry has a 4-panelled door with one large light surmounted by a transom light and flanked by pilasters rising to a full entablature. The windows are nine-over-six on the first floor and six-over-six on the second, all framed by shutters and architrave trim. The eaves treatment consists of a molded cornice with imitation rope-molding below. The main block rests on a fieldstone foundation.

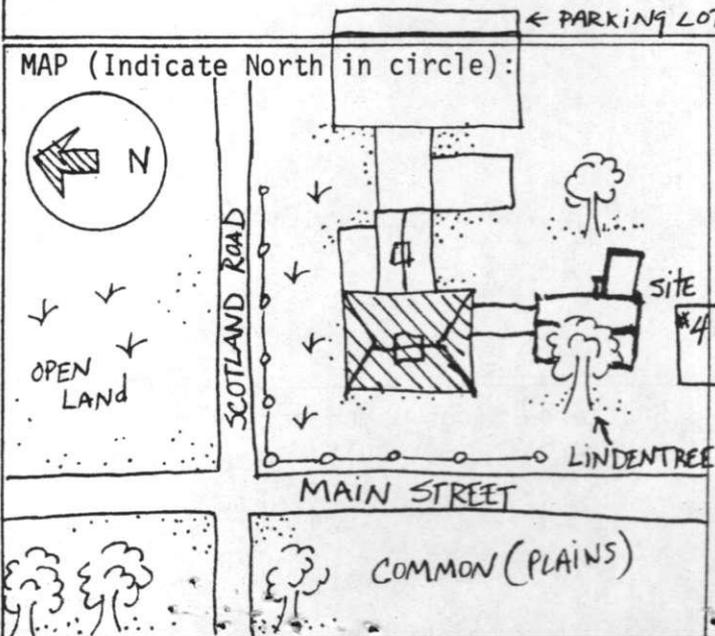
A 2-story, gable-roofed ell projects to the east. It has a 1-story, enclosed porch on its north elevation. A second ell extends to the east of the first. It has a gable-roof, and nine-over-six windows. A 1-story wing projects from the south elevation of this ell.
