HISTORIC PRESERVATION ASSISTANCE PROJECT

Strafford Rockingham Regional Council

TOWN: Kingston	COUNTY: Rockingham
SURVEY NUMBER: 79 *	
COMMON NAME: Pilgrim United Church of Christ	
HISTORIC NAME: Methodist Church	
LOCATION: W side of Church St., .16 miles S of intersection of Church & Cottage.	
OWNER: Pilgrim Church of Christ 12 Church St.	
ADDRESS: Kingston, NH.	
MAP & PARCEL #: U-10/15	
DATE: c. 1899	
SOURCE: History of Kingston	
STYLE: Colonial Revival

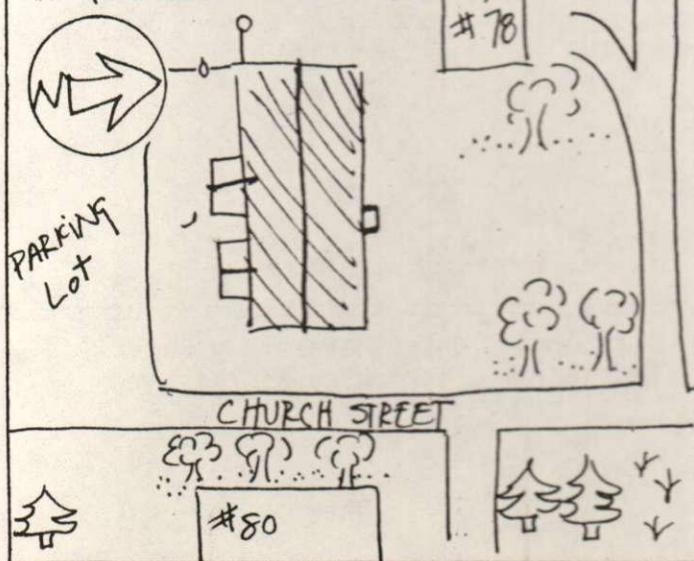
MAP (Indicate North in circle):

.6 acres bounded to the N-Cross, S-Town of Kingston, E-Church Street, W-Greenwood Pond.

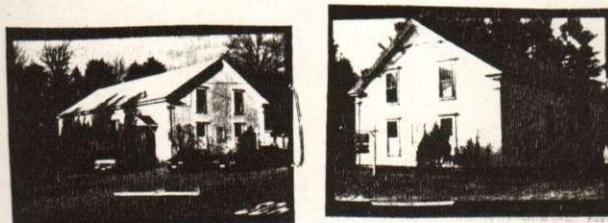
PHOTO

Description of View: Front-east
Side-south

The Pilgrim United Church of Christ is a 1½-story, Colonial Revival style structure. The sidehall entry, located on the south elevation, has double-leaf doors, each with one light. Above the door is a gable-roofed door hood. All of the windows have eight-over-two sash. The windows in the gable-end, which is oriented toward the street, have projecting caps, while those on the north and south elevations have pedimented lintels.

The medium-pitch roof is topped by a narrow chimney with a vault. The eaves treatment consists of a boxed cornice with a wide frieze and gable-end returns, supported by wide cornerboards capped with moldings to suggest pilasters. The main block rests on a fieldstone foundation.

A 1-story, gable-roofed enclosed porch is located on the south elevation. It has clapboard siding and rests on a concrete block foundation.
