HISTORIC PRESERVATION ASSISTANCE PROJECT

TOWN: Kingston	COUNTY: Rockingham
SURVEY NUMBER: 108	
COMMON NAME: The Weyler House	
HISTORIC NAME: Silloway House	
LOCATION: S. side Scotland Road, .03 mi. W. of intersection of Depot Road	
OWNER: Kenneth Weyler	
ADDRESS: 23 Scotland Rd., Kingston, NH	
MAP & PARCEL #: U8-3	
DATE: C. 1840	
SOURCE: Inspection	
STYLE: Greek Revival

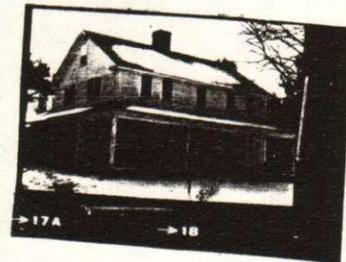
PHOTO

Description of View:
Front (N) Side (E)

The Weyler house is a 2 $\frac{1}{2}$ story Greek Revival style structure. The 4 panelled center entry door contains one large light, is flanked by shutters, and is sheltered by a 1 story, flat roofed open porch supported by round tapering columns. Windows have two over two sash, and the ones on the first story of the front facade are surmounted by window caps. A window in the gable end has small, stained glass lights surrounding a large fixed light. The medium pitched roof is topped by one large corbel capped chimney, and the treatment at the eaves consists of a boxed cornice with gable end returns. A 1 story gable roofed ell has clapboard siding, a boxed cornice, and a rusticated cement block foundation. It attaches to a 1 $\frac{1}{2}$ story gable roofed barn. The Barn has clapboard siding, a boxed cornice, and horizontally sliding vertical board doors. It is topped by a decorative louvered cupola which has a hipped roof surmounted by a weathervane.
