CULTURAL RESOURCES SURVEY FORM

SURVEY NUMBER: 154A

COMMON NAME: Dunbar House

HISTORIC NAME: A. C. Chase House

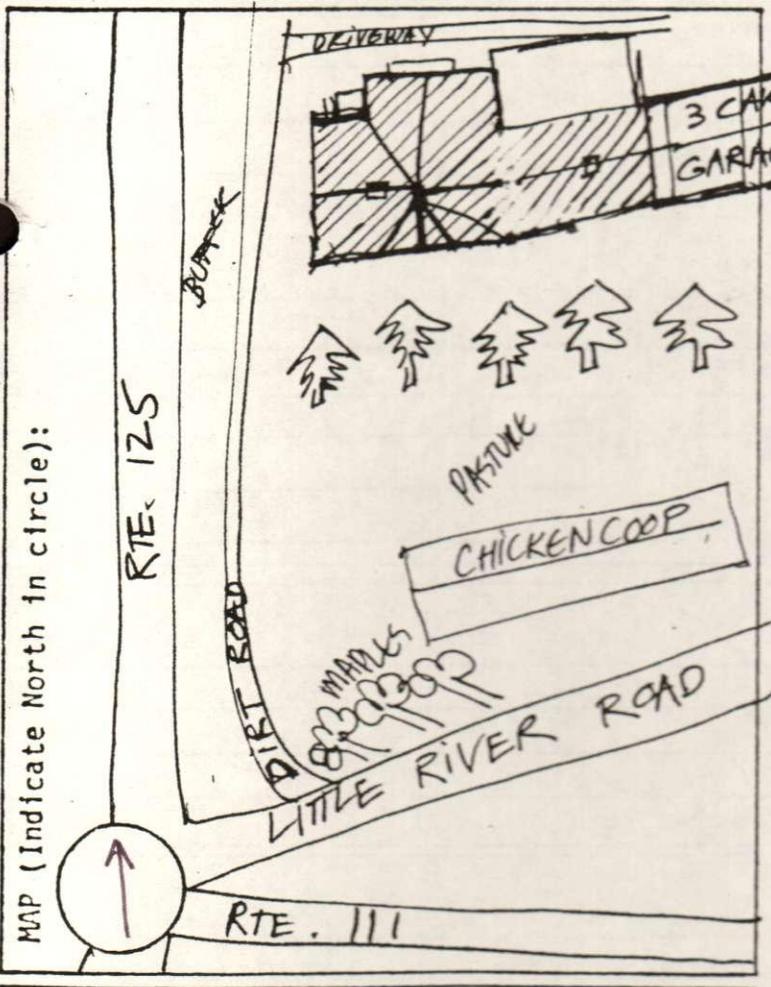
PHOTO:

1. STYLE _____	BUILDING TYPE _____	date
2. # STORIES <u>2½</u>	DIMENSIONS <u>25 x 50</u>	BAYS <u>Irreg.</u> FORM <u>Rectangular</u>
3. FOUNDATION <u>New block</u>	4. STRUCTURE <u>Balloon</u>

5. WALLS: Sheathing <u>Clapboard</u>		Ornamentation <u>Cornerboards, frieze</u>
6. ROOF: Type <u>Cross gable</u>		Sheathing <u>Asphalt</u>
Dormers/Cupolas _____		Details _____

7. CHIMNEYS: # <u>2</u> Location <u>Brick interior</u>		Materials _____
Description <u>Stove corbel</u>		
8. EAVES TREATMENT: <u>Lateral Molded cornice, boxed, projecting with returns.</u>		
Gable End _____

9. WINDOWS: Placement <u>Irregular</u>		Shape <u>Rectangular</u> Sash <u>2/2</u>
Surrounds <u>Plain boards with 2nd story small cape</u>		
10. ENTRIES: MAIN: Location <u>Left wing; porch</u>		Door <u>Single lite victorian panel</u>
Surround: Flanked <u>Simple board surrounds</u>		Topped <u>4 horizontal panels.</u>
Framed _____		
OTHERS: # _____ Location _____		Surrounds _____
Shed roof enclosed porch supported by clapboard parapet on centerblock foundation		
Front shed roof entry porch with square posts
