Hanson House

**53 Marshall Road
August 2021**

At Risk Historical House Documentation

At Risk House Report

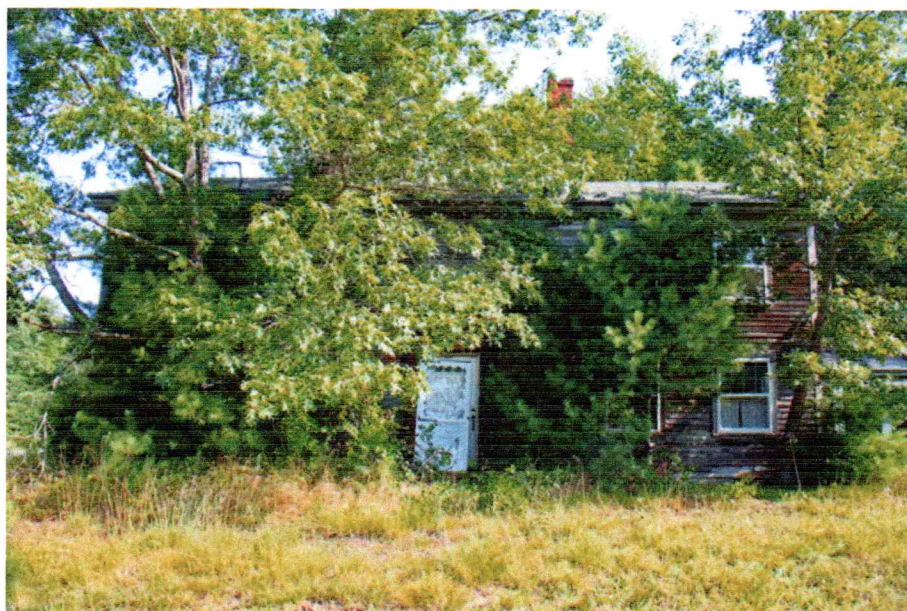
Picture of the House Front taken in 2019 by Walt Roy

By 2019, the Heritage Commission had been trying to get into the Hanson House to document it for posterity. From its outward appearance, it was obviously deteriorating beyond repair.

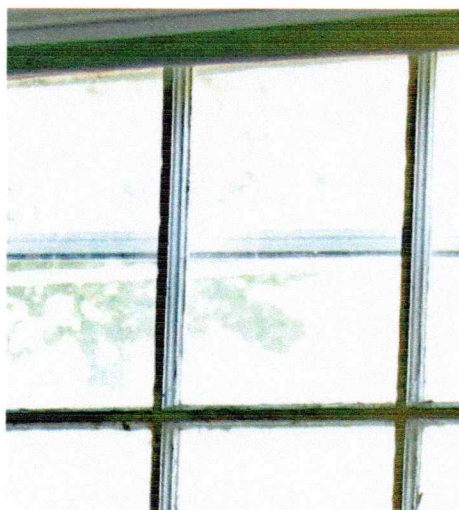
*Muntins on 8 over 1 downstairs window
Photo by Walt Roy(2019), modified by Bob Bean(2021)*

The window muntins have a flat outer surface and overall shape typical of after 1888 and still common today. However the original windows could have been changed.

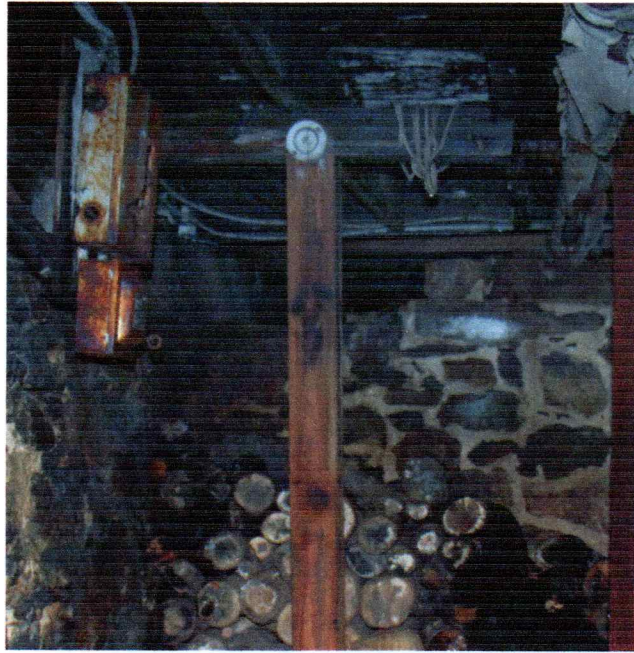
Non supporting stone wall in basement. Photo by Walt Roy 2019.

In addition there was as old stone wall in the basement that was not in use. I believe it was evidence of an earlier foundation.

In the basement there was an old stone foundation about the midpoint of the house. I think it was evidence of an earlier smaller house. There are stories that the house burned at one point, and was rebuilt. I suspect the rebuild was done ca 1900 in the Colonial Revival style.

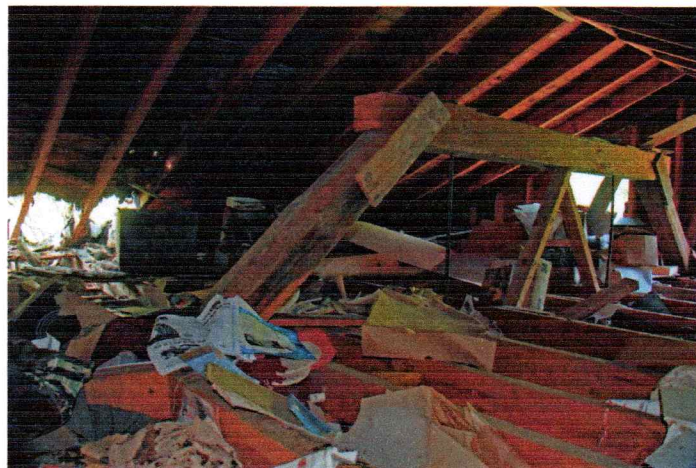
Truss used to hold up ceiling in bedroom below. By Walt Roy 2019.

Further there was an early truss-like beam in the attic. I don't believe that structure is typical of an 1809 Federalist structure as proposed by the 1983 survey.

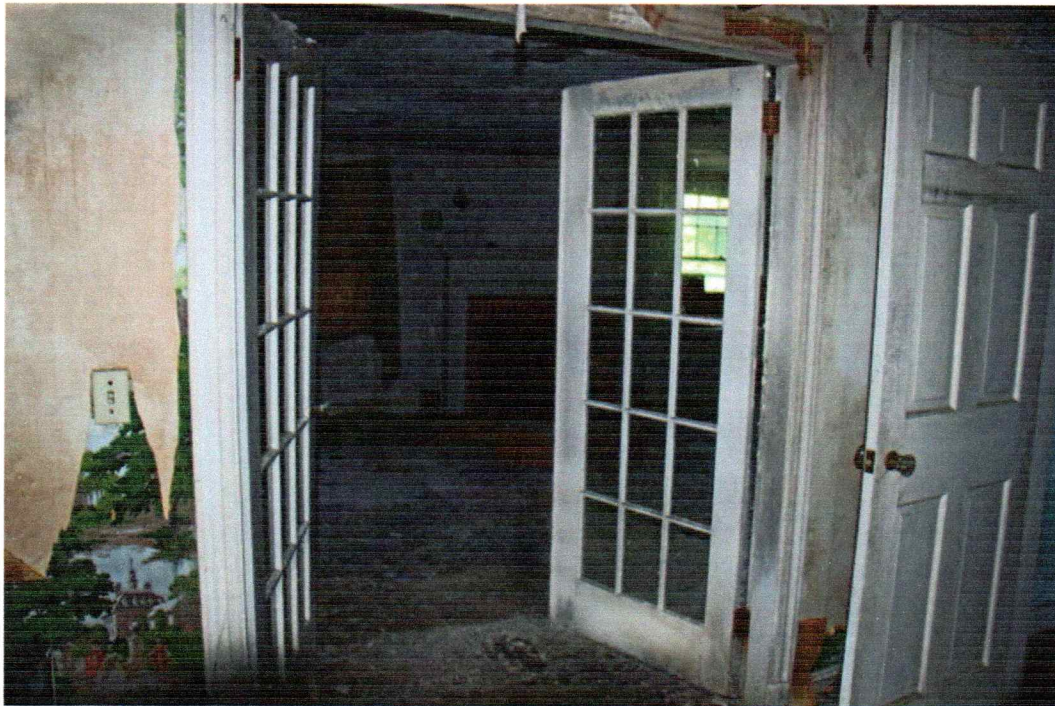
View of the Parlor from the front entry in 2019, Photo by Walt Roy

View of the French doors opening from the front hallway into the parlor. Note the fireplace on the far wall.

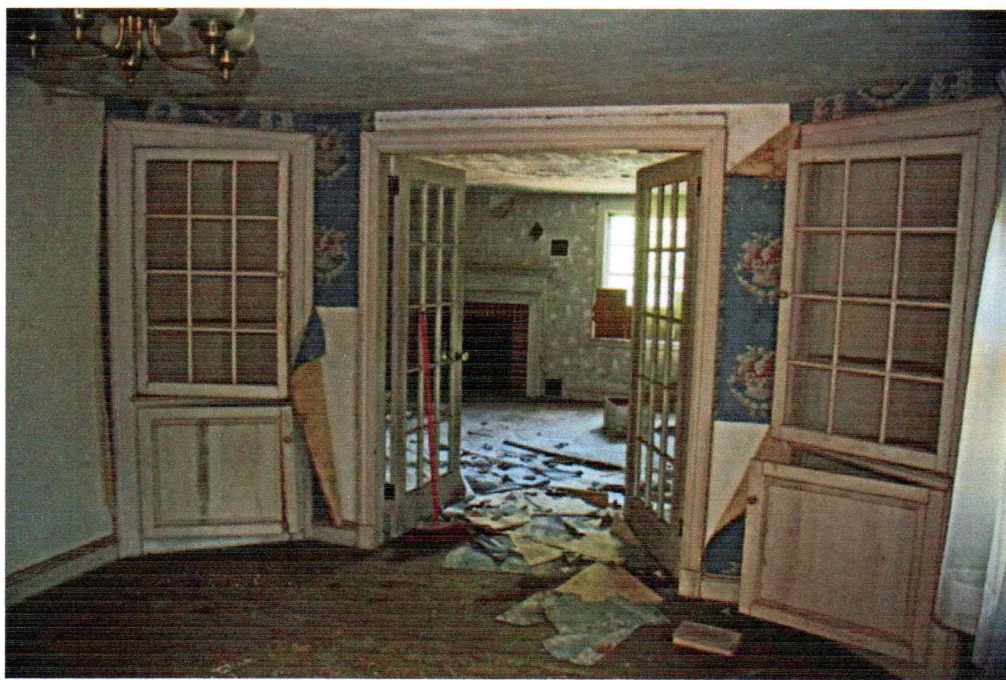
View from the dining room looking into the Parlor in 2019, photo by Walt Roy.

Note the built in cupboards, and fancy French doors. A very formal entry.

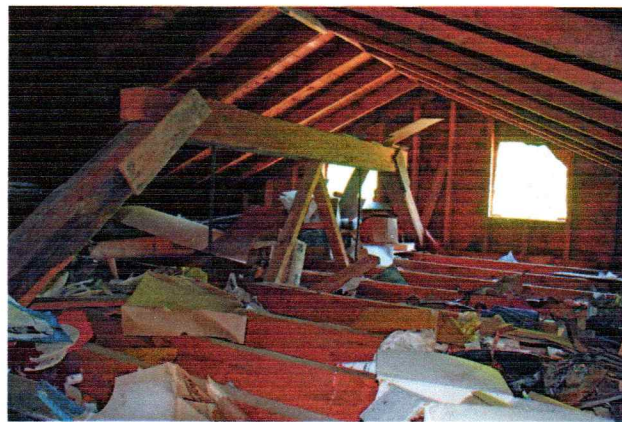
Hanson House Unusual Framing

On the first floor we had a room (Parlor) that ran the whole width of the house (27 feet). But on the second floor we had a wall across the middle, between the two bedrooms. The second floor wall and the ceiling on the ground floor were held up by steel rods that were hung from the beam in the attic shown in the picture. A close look at the beams shows them to be Up & Down saw cut with wide kerfs. That could have been made at any date, and the beam could just have been reused.

This support technique is not common. In addition the roof rafters and floor joists seem to have been cut with a circular saw. That alone could date this building to ca 1900 when circular saw mills were just coming into use and popularity. The Cheney mill was built in 1919 and was considered state of the art with its new circular saw.

- We were unable to confirm when the house first was owned by the Hanson Family, or how the family came into ownership.
- Research into genealogy brought us back to Samuel Hanson (1814-????), but we were unable to find his ancestors.
- The construction details, especially that standing bridge in the attic should be further researched. It is a very unusual feature, and this writer has no knowledge of when or how it came to be used.

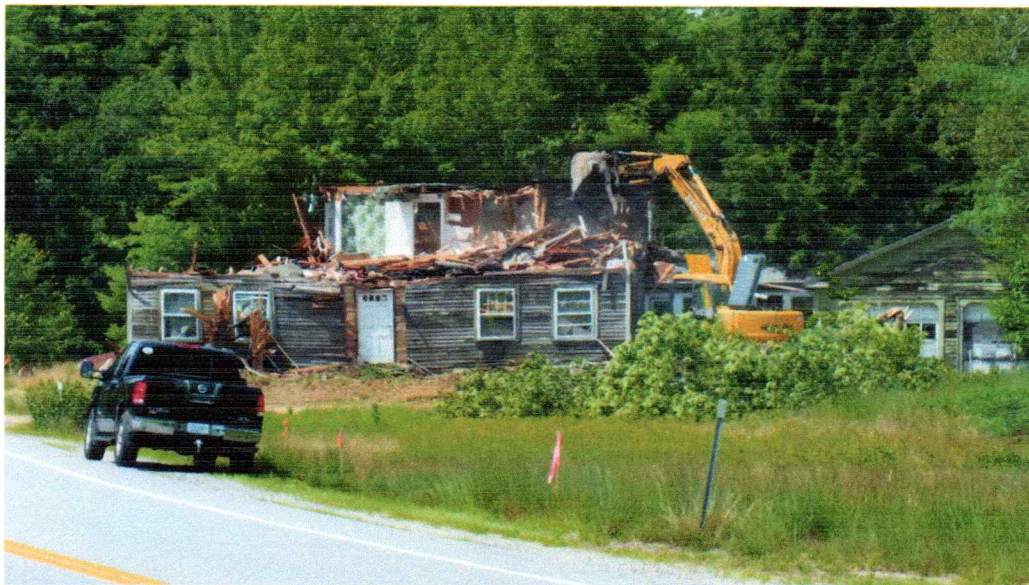
Photo of the House being demolished in July 2020. Photo by Ernie Landry.

In July of 2020 over a 2-3 day period the Hanson house was torn down. Replacing it is now a grouping of modern houses.
