## HISTORIC PRESERVATION ASSISTANCE PROJECT

Strafford Rockingham Regional Council

TOWN: Kingston	COUNTY: Rockingham	UTM: Z19 /E 332550 /N 4755500
SURVEY NUMBER: 39*		USGS QUAD: Kingston Quad 7.5' series
COMMON NAME: The Roberts House		FUNCTIONAL TYPE: Residential
HISTORIC NAME: "Old Wilkinson Place"		PRESENT USE: Residential
LOCATION: NW side Depot Rd., .1 Miles E. of Intersection Main & Depot		ARCHITECT/BUILDER: Unknown
OWNER: Ralph & Marcia Roberts		CONDITION: Exc. <u>Goody</u> Fair <u>Poor</u> Ruins
ADDRESS: 6 Depot Road, Kingston, NH		INTEGRITY: Original Site <u>X</u> Moved (When: )
MAP & PARCEL #: U10,33		Major alterations & date: Remodeled c.1860/1870, and at many other times.
DATE: C. 1820		LEVEL/SIGNIFICANCE: Natl State Local <u>X</u>
SOURCE: Assessors Office, Kingston		
STYLE: Federal

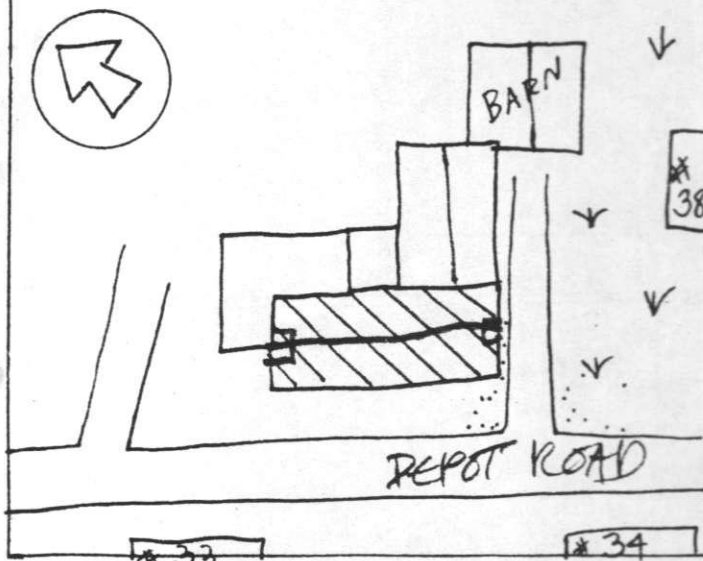
PHOTO

Front, South Side, East

The Roberts House is a 2-story twin-chimney Federal style structure. The center entry is sheltered by a 1-story vestibule with a multi-light door. Windows are one-over-one and two-over-two with plain surrounds. The low-pitched roof is topped by two chimneys with corbeled caps. The cornice treatment consists of close raking eaves and close molded lateral eaves.

The 2 story ell has the same windows, siding, and eaves treatment as the main block. There is a 1-story wing/ell on the north and east elevations that has the same siding and cornice treatment.
