HISTORIC PRESERVATION ASSISTANCE PROJECT

Strafford Rockingham Regional Council

TOWN: Kingston	COUNTY: Rockingham	UTM: Z 19 /E 332600 /N 4756075
SURVEY NUMBER: 50*		USGS QUAD: Kingston Quad 7.5' series
COMMON NAME: Saunders House		FUNCTIONAL TYPE: Dwelling
HISTORIC NAME: Prescott House		PRESENT USE: Residential
LOCATION: E side of Main Street, .33 miles N of intersection of Main & Depot.		ARCHITECT/BUILDER: Unknown
OWNER: Peter Saunders		CONDITION: Exc. <u>Good</u> Fair <u>X</u> Poor Ruins
ADDRESS: 187 Main Street Kingston, NH		INTEGRITY: Original Site <u>X</u> Moved (When:)
MAP & PARCEL #: R-34/72		Major alterations & date: Two houses put together after 1892
DATE: c. 1850		LEVEL/SIGNIFICANCE: Natl State Local <u>X</u>
SOURCE: Inspection		
STYLE: Vernacular

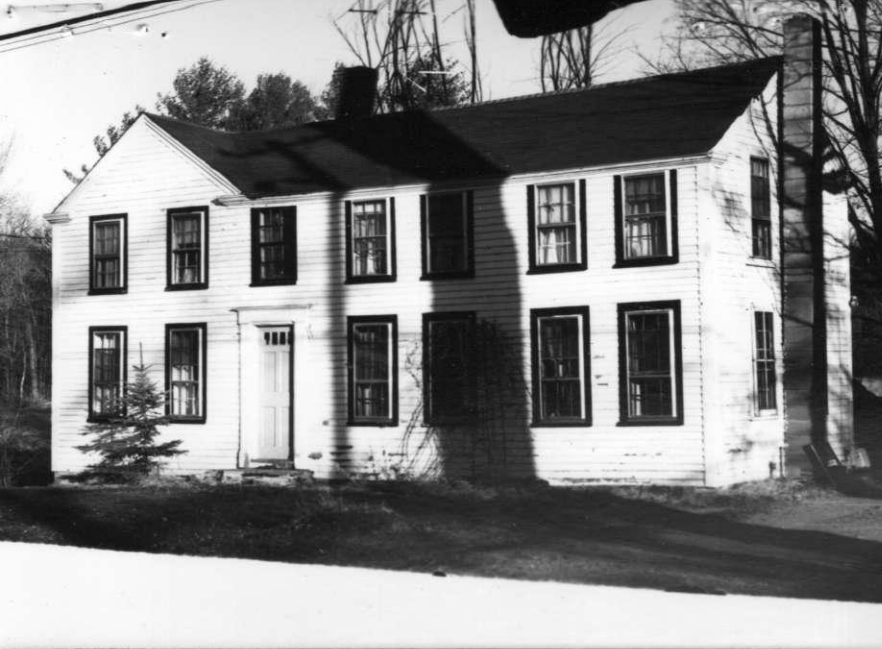
PHOTO

Description of View: Front-west
Side-south

The Saunders House is a simple 2-story vernacular structure. The offset entry has a four-panel door with four lights and is flanked by fluted pilasters rising to an entablature. The first-story windows are nine-over-six and those on the second story have six-over-six sash. The low-pitched roof has a large offset chimney and the roofing has close raking and lateral eaves with slight gable-end returns. The structure rests on a brick foundation.

A 2-story, gable-roofed wing extends to the north. It has the same window and cornice treatment as the main block and rests on a brick foundation.

An enclosed, shed-roofed porch extends to the southeast and an attached 1-story shed is located to the east.
