HISTORIC PRESERVATION ASSISTANCE PROJECT

Strafford Rockingham Regional Council

TOWN: Kingston	COUNTY: Rockingham	UTM: Z 19 / E 332175 / N 4755800
SURVEY NUMBER: 78 *		USGS QUAD: Haverhill Quad 15' Series
COMMON NAME:		FUNCTIONAL TYPE:
HISTORIC NAME:		PRESENT USE:
LOCATION: West side of Church St. .15 miles south of inter. Church & Cottage		ARCHITECT/BUILDER: Unknown
OWNER: Cecil Cross		CONDITION: Exc. <input checked="" type="checkbox"/> Good <input type="checkbox"/> Fair <input type="checkbox"/> Poor <input type="checkbox"/> Ruins <input type="checkbox"/>
ADDRESS: 14 Church St., Kingston, NH		INTEGRITY: Original Site <input type="checkbox"/> Moved <input type="checkbox"/> (When: <input type="checkbox"/>)
MAP & PARCEL #: U-10, plot 16		Major alterations & date: <input type="text"/>
DATE: c. 1900		LEVEL/SIGNIFICANCE: Natl <input type="checkbox"/> State <input type="checkbox"/> Local <input type="checkbox"/>
SOURCE: Herb Buhert & Scott Novak		
STYLE: None

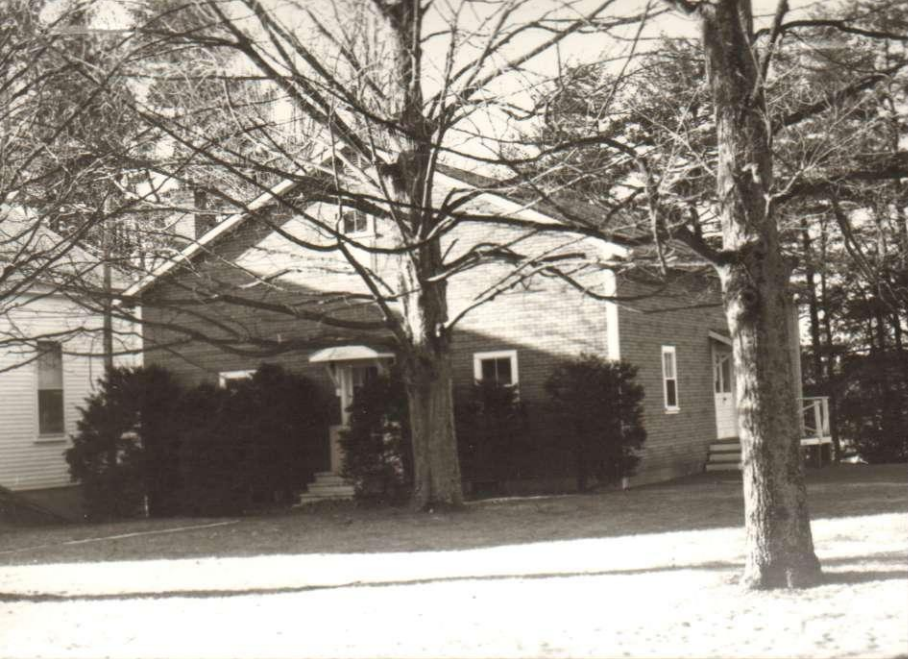
PHOTO

Description of View: Front-north
Side-northPhotographer: Scott Novak
Negative with: S.R.R.C.
Negative File Number: K-80-3c/18-18A

1½ story frame building.

Gable roof with simple overhangs.

Street face is center door with multipaned glass topped by small gable roof doorhood supported by truss brackets. Flanked by small square windows 2/1 with plain surrounds. Same experience on lateral side except major entry has double leaf doors with shed roof, doorhood supported by truss brackets and giving forth onto small deck.
