HISTORIC PRESERVATION ASSISTANCE PROJECT

Strafford Rockingham Regional Council

TOWN: Kingston COUNTY: Rockingham SURVEY NUMBER: COMMON NAME: The Jennings House HISTORIC NAME: J. Severance House LOCATION: S. side Danville Rd., .05 Mi. E. Intersection Danville Rd. & Cheney Mill Rd. OWNER: Dana Jennings ADDRESS: 60 Danville Rd., Kingston, NH MAP & PARCEL #: R22-41 DATE: C. 1840 SOURCE: Inspection STYLE: Greek Revival Cape

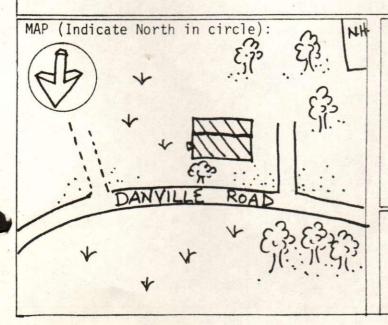
PHOTO

Front (N) Side (E)

ADDITIONAL ARCHITECTURAL AND STRUCTURAL DESCRIPTION:
The Jennings house is a $l_2^{\frac{1}{2}}$ story, saltbox cape built in the greek revival style. The center entry has a 6 panelled door flanked by full height sidelights. All of the windows have either two over one or two over two sash. An exterior, concrete block chimney rises along the east wall and the roofline has a boxed cornice on the lateral eaves and close raking eaves. The structure rests upon a fieldstone foundation.
RELATED STRUCTURES AND CONTEXT:
BOUNDARY AND ACREAGE DESCRIPTION: 1 Acre. Bounded on the N. by Danville Rd. S. by Coburn, Crough, and Wilson, E. by Danville Road, W. by Crough.
REFERENCES:
1856 Map J. Severance, 1892 Map J. Severance
STATEMENT OF SIGNIFICANCE (Evaluation & Historical Associations):
The J. Severance House is a vernacular example of the Greek Revival cape style whose most important feature is the central entry flanked by full length sidelights.
