HISTORIC PRESERVATION ASSISTANCE PROJECT

SURVEY NUMBER: 136

COMMON NAME: The Childs House

HISTORIC NAME: Colcord/Patten House

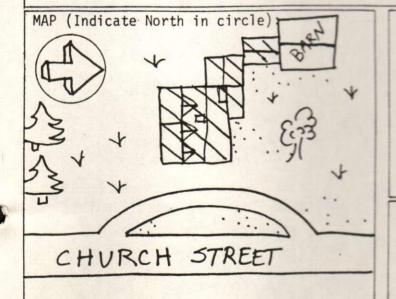
Description of View:

Front (S) Side (E)

The Childs house is a  $1\frac{1}{2}$  story cape style structure. The 6-panelled entry door is located in the enclosed porch. Some windows have two over one sash, some have 12/12,

and both are flanked by shutters. The steeply pitched roof is topped by a corbel-capped chimney, and the eaves treatment consists of a boxed cornice with gable end returns. The are three gable roofed wall dormers on each the north and the south roof slopes. They each contain one narrow, vertical window.

The 1 story, shed roofed wing on the south elevation has the same siding, windows and foundation as the main block.

There is one shed roofed, I story, open porch on each the north and the south elevation. A  $l_2^{\frac{1}{2}}$  story gable roofed ell has a 6 panelled door, two over one sash, wood shingle siding and a stone foundation. It has an attached I story gable roofed shed.
