CULTURAL RESOURCES SURVEY FORM

COMMON NAME: The Berry House

HISTORIC NAME J. Randall House

LOCATION: On W. side of Church St., at its
intersection w/Rte. 107OWNER: Richard & Charlene Berry
ADDRESS: 52 Church St., Kingston, NH

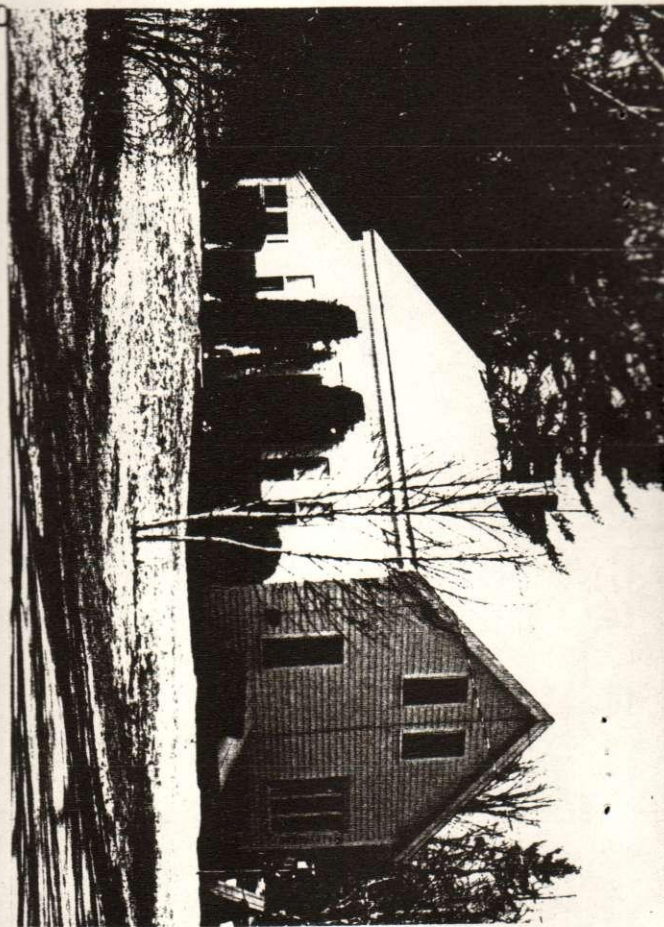
PHOTO

Photographer Facing: (facade) - South

1. STYLE	Vernacular Cape	BUILDING TYPE	Residence	date			
2. # STORIES	1½	DIMENSIONS	20 x 15	BAYS	5 x 2	FORM	Rectangle
3. FOUNDATION	Stone	4. STRUCTURE	Post & beam

5. WALLS: Sheathing	Clapboard	Ornamentation	Plain cornerboards				
6. ROOF: Type	Gable	Sheathing	Asphalt				
	Dormers/Cupolas	1	Details				
7. CHIMNEYS: #	1	Location	Center	Materials	Brick		
	Description

8. EAVES TREATMENT: Lateral	Narrow boxed, narrow overhanging						
Gable End	Narrow boxed cornice with short returns.						
9. WINDOWS: Placement	Symmetrical	Shape		Sash	2/2		
Surrounds	Plain board

10. ENTRIES: MAIN: Location	Central (S. side)	Door	Modern (6 panel ½ round)				
Surround: Flanked		Topped					
Framed	Plain board						
OTHERS: #	1	Location	North side	Surrounds

11. PORCHES/HOODS: #	1	Style/Roof Type	Aluminum doorhood over North entry.				
	Location(s)	North elevation	Supports				
	Other Features						
12. BAY WINDOWS/TOWERS: #	1	Location		Stories		Shape	
	Description(s)	Large flat casement window on East side.

18. ARCHITECTURAL IMPORTANCE/INTEGRITY Undetermined history. House has received much attention and is in such good condition that historic fabric is difficult to see.
