HISTORIC PRESERVATION ASSISTANCE PROJECT

Strafford Rockingham Regional Council

TOWN: Kingston	COUNTY: Rockingham	UTM: Z 19 /E 331525 /N 4757150
SURVEY NUMBER: 145		USGS QUAD: Haverhill Quad 15' series
COMMON NAME: The Borthwick House		FUNCTIONAL TYPE: Blacksmith Shop
HISTORIC NAME: Marshall Blacksmith Shop		PRESENT USE: Residence
LOCATION: S. side Marshall Road, .48 Mi. E. of intersection Thorne Road		ARCHITECT/BUILDER: James Marshall
OWNER: Ada Borthwick		CONDITION: Exc. <u>X</u> Good <u>Fair</u> Poor Ruins
ADDRESS: 18 Marshall Rd., Kingston, NH		INTEGRITY: Original Site <u>X</u> Moved (When:)
MAP & PARCEL #: R33-25		Major alterations & date: ell added 1949
DATE: C. 1840		LEVEL/SIGNIFICANCE: Natl State Local <u>X</u>
SOURCE: Inspection		
STYLE: Greek Revival

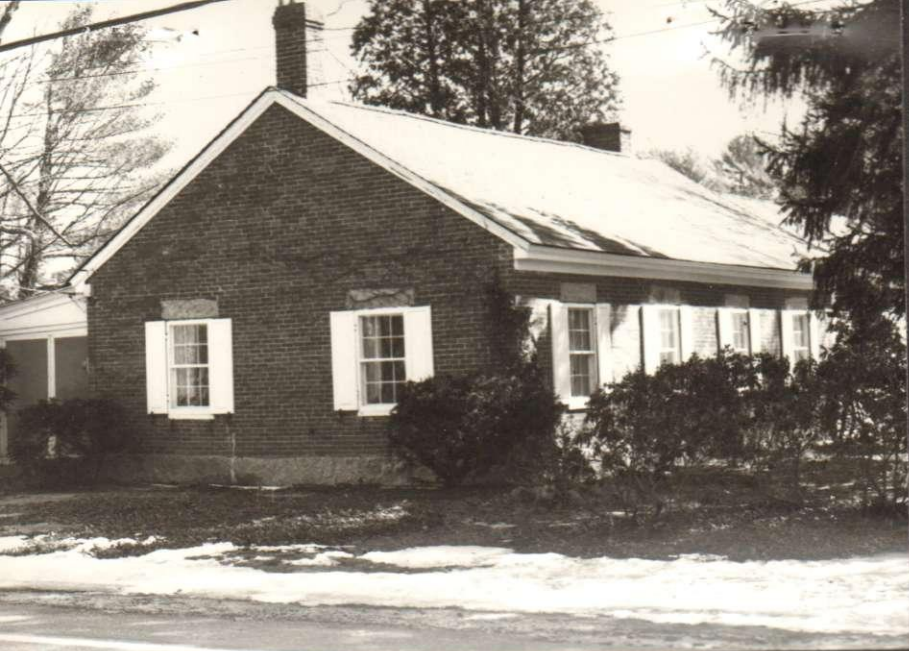
PHOTO

Front (N) Side (W)

The Borthwick house is a 1 story, gable roofed brick, cape style house. The center entry located on the east elevation has a 4 panelled door flanked by full length sidelights and sheltered by a 1 story, shed roofed enclosed porch. Added when converted to summer home. All of the windows have six over six sash surmounted by granite lintels and framed by panelled shutters. The medium pitch roof is topped by twin, tall, corbel-capped chimneys. The house rests on a granite slab foundation. The 1 story, gable roofed ell has clapboard siding, six over six windows framed by shutters and a cement foundation. It has an oriel window on its east elevation and its roof is topped by a narrow corbel-capped chimney.
