## HISTORIC PRESERVATION ASSISTANCE PROJECT

Strafford Rockingham Regional Council

TOWN: Kingston	COUNTY: Rockingham	UTM: Z 19 /E 336500 /N 4757950
SURVEY NUMBER: 155		USGS QUAD: Haverhill Quad 15' series
COMMON NAME: The Tuttle House		FUNCTIONAL TYPE: Dwelling
HISTORIC NAME: The Bragdon House		PRESENT USE: Residential
LOCATION: SE side Exeter Rd., .07 Mi. NE intersection South Road		ARCHITECT/BUILDER: Unknown
OWNER: Dwight Tuttle		CONDITION: Exc. <input type="checkbox"/> Good <input checked="" type="checkbox"/> Fair <input type="checkbox"/> Poor <input type="checkbox"/> Ruins <input type="checkbox"/>
ADDRESS: 127 Exeter Rd., Kingston, NH		INTEGRITY: Original Site <input checked="" type="checkbox"/> Moved <input type="checkbox"/> (When: <input type="text"/> )
MAP & PARCEL #: R37-21		Major alterations & date: Asbestos shingle siding applied date unknown
DATE: C. 1820		LEVEL/SIGNIFICANCE: Natl <input type="checkbox"/> State <input type="checkbox"/> Local <input checked="" type="checkbox"/>

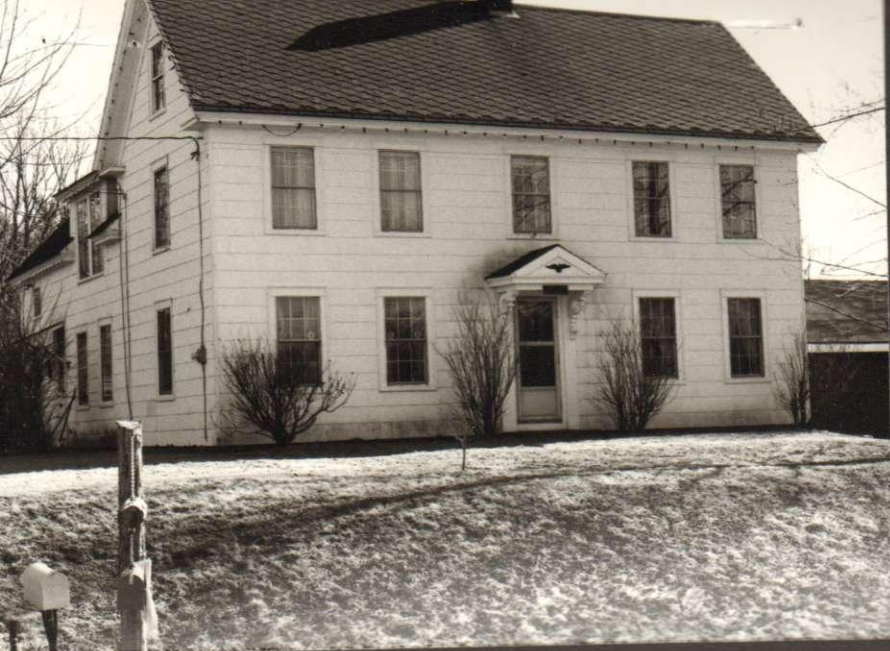
PHOTO

Front (NW) Side (NE)

The Tuttle house is a 2½ story, 5 bay, Federal style structure which has been altered through later remodeling, including the addition of asbestos shingle siding. The center entry has a 2 panelled (victorian era) door with two lights which is surmounted by a gable roofed doorhood supported by heavy brackets with ornamental drop pendants. All of the windows have six over six sash framed by architrave trim. The medium pitch roof is topped by a narrow, corbel capped chimney and the eaves treatment consists of a boxed cornice with a narrow frieze and gable end returns. The house rests on a fieldstone foundation. A 1½ story, gable roofed ell projects to the southeast. To the southwest is a 1 story gable roofed wing.
