HISTORIC PRESERVATION ASSISTANCE PROJECT

Strafford Rockingham Regional Council

TOWN: Kingston	COUNTY: Rockingham
SURVEY NUMBER: 30*	
COMMON NAME: Daley House	
HISTORIC NAME: <u>Congressional Parsonage</u>	
LOCATION: E side of Main St., .25 miles N of intersection of Main & Bartlett	
OWNER: Town of Kingston	
ADDRESS: 165 Main Street Kingston, NH	
MAP & PARCEL #: U-10/38	
DATE: c. 1830	
SOURCE: Inspection	
STYLE: Federal

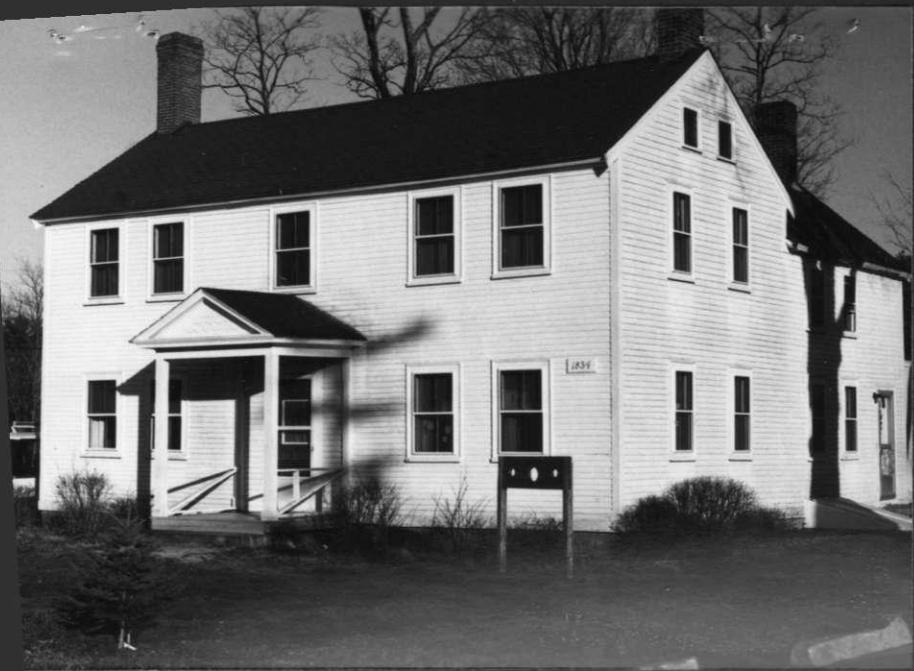
PHOTO

Description of View: Front-west
Side-north

The Daley house is a 2½-story Federal style structure. The central entry has a multi-panelled door with one large light, and is sheltered by a pedimented gable-roofed porch. Windows are all two-over-two with architrave trim. The medium-pitched roof is topped by two end-placed chimneys with corbeled caps. The cornice treatment consists of close raking eaves and a three-part molding on the lateral eaves.

A 2-story ell has the same windows and cornice treatment as the main block, and connects to a 2-story gable-roofed shed.
