HISTORIC PRESERVATION ASSISTANCE PROJECT
 Strafford Rockingham Regional Council
 1 Water Street, Exeter, New Hampshire
 Phone: (603) 778-0885

| COMMON NAME: Kingston Museum | | FUNCTIONAL TYPE: Firehouse |
| HISTORIC NAME: Kingston Firehouse | | PRESENT USE: Museum (Historical) |
| LOCATION: 3 Depot Road | | ARCHITECT/BUILDER: Unknown |

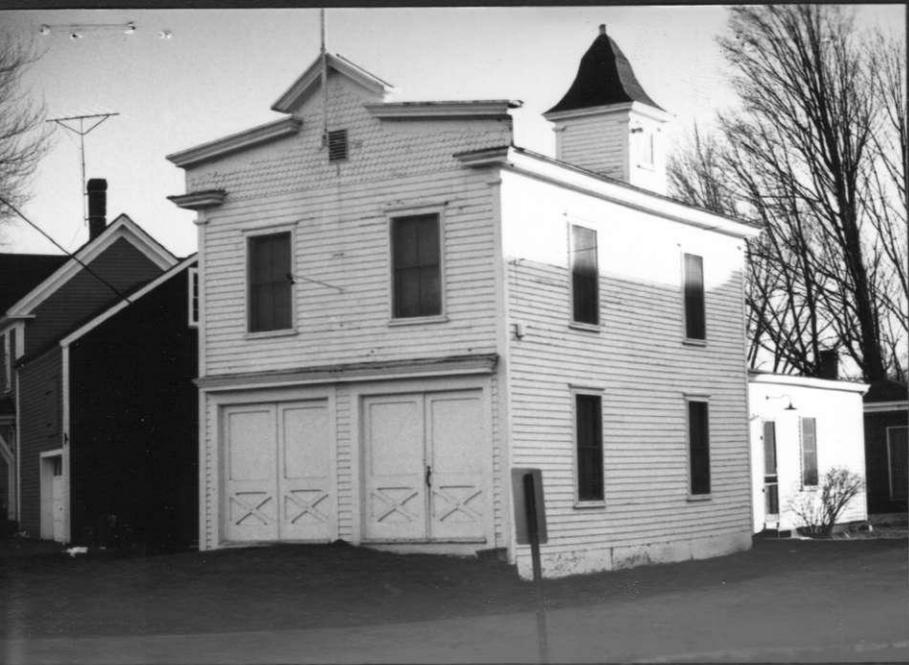
PHOTO

Description of View: Front-northwest
 Side-southwest

This interesting Victorian era firehouse has gable front orientation to the street and two wooden, swinging-type bay doors surmounted by an entablature in the gable-end facade. Windows are two-over-two and six-over-six with architrave trim and window caps. The eaves treatment consists of a boxed cornice. The front facade is topped by gabled parapet with vergeboard, and the rear facade has a square tower with a bellcast roof. The tower has fixed four-light windows with window caps, and the eaves treatment consists of a boxed cornice.

There is a 1-story ell with the same siding, cornice, and foundation (brick) as the main block.
