HISTORIC PRESERVATION ASSISTANCE PROJECT

TOWN: Kingston	COUNTY: Rockingham	UTM: Z 19 /E 332375 /N 4755925
SURVEY NUMBER: 66*		USGS QUAD: Haverhill Quad 15' Series
COMMON NAME: Colcord Hall		FUNCTIONAL TYPE: Educational
HISTORIC NAME: Unknown		PRESENT USE: High School Administration
LOCATION: west side of Main St. (set back) .18 miles S. of inter. of Main & Depot		ARCHITECT/BUILDER: Unknown
OWNER: Sanborn Regional High School 178 Main St.		CONDITION: Exc. <u>Good</u> <input checked="" type="checkbox"/> Fair <u>Poor</u> <u>Ruins</u>
ADDRESS: Kingston, NH.		INTEGRITY: Original Site <input checked="" type="checkbox"/> Moved <u> </u> (When: <u> </u>)
MAP & PARCEL #: R-34/17		Major alterations & date: <u> </u>
DATE: c. 1913		
SOURCE: History of Kingston		
STYLE: Colonial Revival		LEVEL/SIGNIFICANCE: Natl <u> </u> State <u> </u> Local <u> </u>

Continuation Sheet #1 SITE 66*

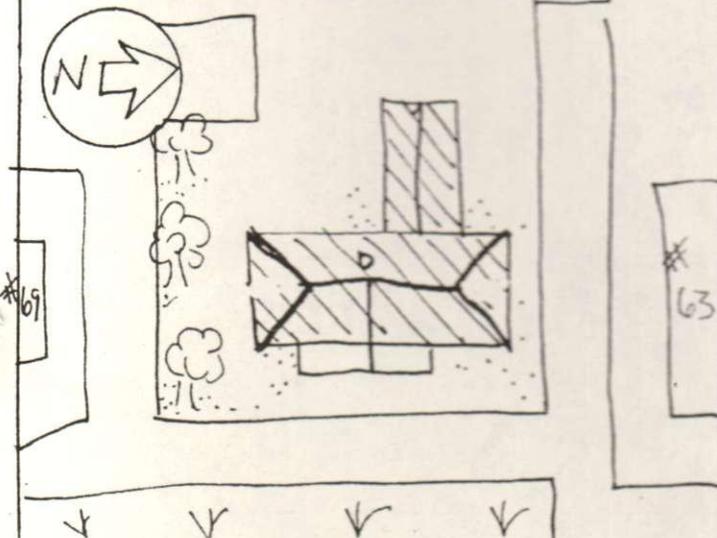
PHOTO

Description of View: Front-east
Side-south

This building is a 2½-story, hip-roofed, Colonial Revival style structure featuring a 2½-story entry pavilion on its main facade. The pavilion is framed by 2-story, fluted, engaged columns resting on brick piers and rising to a closed pediment containing a Palladian window. The double-leaf doors on the pavilion are flanked by fluted, tapering pilasters and sheltered by a 1-story, gable-roofed, open porch. All windows on the pavilion have criss-cross sash above and one light below, with the first story windows having recessed panels below.

All of the windows on the main block have four-over-two sash framed with architrave trim and the first story windows are capped by denticulated entablatures. The eaves treatment on the entry pavillion and main block consists of a boxed cornice with a wide, denticulated frieze. The hip-roof is topped by a narrow, corbel-capped chimney and has two, hip-roofed, 3-bay dormers on its north and south elevations. On the west elevation is a 1-bay, gable-roofed dormer with a pedimented gable. All of the dormers have the same eaves treatment as the main block.

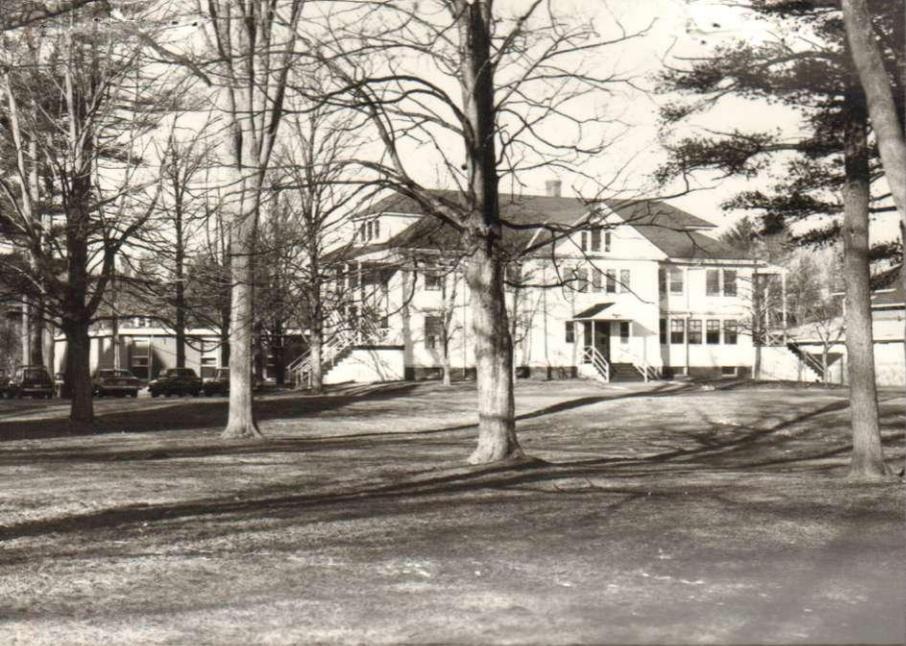
The south elevation has a 2-panelled door with six lights topped by a semi-circular, radiating fan light and flanked by fluted, tapering pilasters. Recent 2-story, open stairways are located on the north and south elevations.

The 1-story, shed-roofed ell has clapboard siding, four-over-two windows, and rests on a brick foundation.
