HISTORIC PRESERVATION ASSISTANCE PROJECT

Strafford Rockingham Regional Council

TOWN: Kingston	COUNTY: Rockingham
SURVEY NUMBER: District 2	15**
COMMON NAME: The Rent House	
HISTORIC NAME: Eugene Prescott House	
LOCATION: N. side Little River Rd. West., .4 miles of intersection w/Little River Rd.	
OWNER: William & Nancy Rent	
ADDRESS: 7 Little River Rd., ^{West} Kingston, NH	
MAP & PARCEL #: R39-17	
DATE: c.1895	
SOURCE: Assessors Office	
STYLE: Late nineteenth century Vernacular

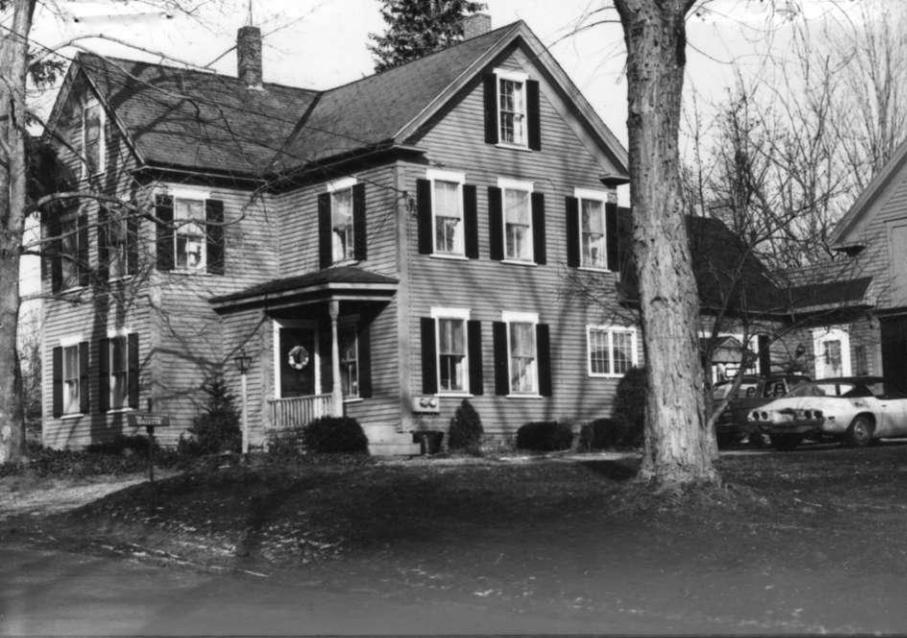
PHOTO

Front (SW) Side (SE)

The Rent house is a 2½ story late nineteenth century vernacular structure. The entry door is sheltered by a 1 story, hip-roofed, open porch supported by a turned column. Windows have two over two sash and are flanked by shutters and surmounted by lintels. There is one window with six over six sash located in the gable end of the main block. The medium pitched roof is topped by two chimneys and the eaves treatment consists of a boxed cornice with gable end returns.

A 1 story, gable roofed ell rests on a concrete block foundation. It has the same eaves treatment and siding as the main block, new windows and an exterior chimney. It attaches to the barn.

A 1 story gable roofed wing rests on a concrete block foundation. It has a boxed cornice and clapboard siding, and features a hayloft door in the gable.

RELATED STRUCTURES AND CONTEXT: An attached 2½ story, gable roofed barn rests on a brick foundation. It has windows with six over six sash, clapboard siding, and a boxed cornice.
