HISTORIC PRESERVATION ASSISTANCE PROJECT

Strafford Rockingham Regional Council

TOWN: Kingston	COUNTY: Rockingham	UTM: Z19 /E 330100 /N 4754500
SURVEY NUMBER: 75		USGS QUAD: Haverhill Quad 15' series
COMMON NAME: Pagliarulo House		FUNCTIONAL TYPE: Residential
HISTORIC NAME: Heath House		PRESENT USE: Residence
LOCATION: W. side Ball Rd., .46 Mi. N. of intersection of Great Pond Road		ARCHITECT/BUILDER: Unknown
OWNER: Sharon Pagliarulo		CONDITION: Exc. <input checked="" type="checkbox"/> Good <input type="checkbox"/> Fair <input type="checkbox"/> Poor <input type="checkbox"/> Ruins
ADDRESS: 60 Ball Rd., Kingston, NH		INTEGRITY: Original Site <input checked="" type="checkbox"/> Moved <input type="checkbox"/> (When: )
MAP & PARCEL #: R01-5		Major alterations & date:
DATE: C. 1790		New clapboard, ell added C. 1970
SOURCE: Assessors Office, Kingston		LEVEL/SIGNIFICANCE: Natl <input type="checkbox"/> State <input type="checkbox"/> Local <input checked="" type="checkbox"/>
STYLE: Federal Half Cape

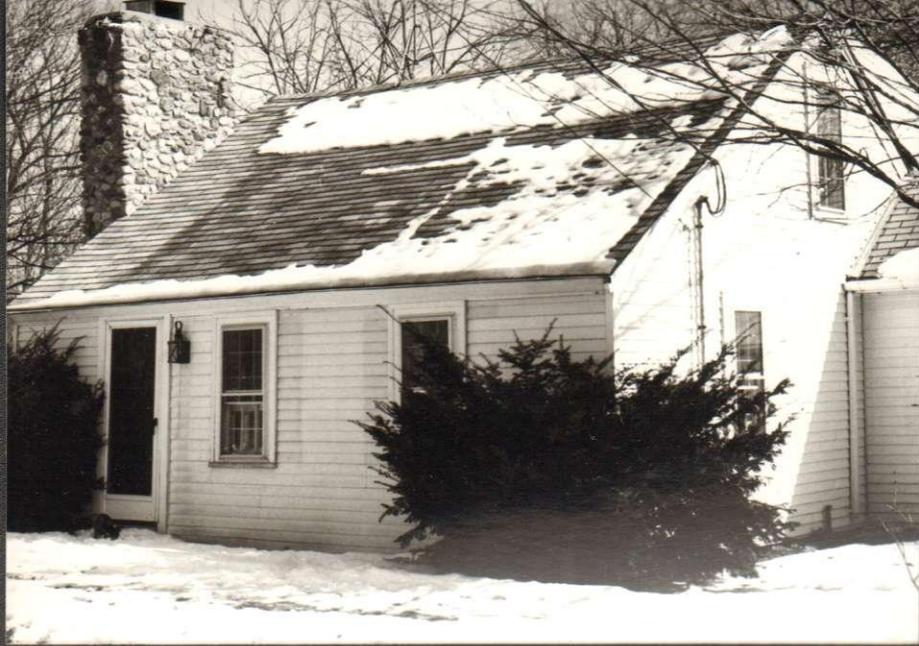
The Paglariuo house is a 1 1/2 story, Gable built in the Federal style. The center entry has a transomed door surmounted by a transom light. West of the window low sills over side rail, framed by woodwork trim. The medium pitched roof is topped by a massive central chimney and the roofline has a boxed cornice on the lateral eaves and close raking eaves. The house is supported by a stone and brick foundation above which is a wooden water table.

The 1 1/2 story, gable roofed ell has clapboard siding, six over nine windows and a recent door. It has a shed dormer on its west elevation and the structure rests on a cement foundation.

Simple vernacular late 18th century structure with an extraordinary fieldstone exterior chimney.
