HISTORIC PRESERVATION ASSISTANCE PROJECT

Strafford Rockingham Regional Council

TOWN: Kingston	COUNTY: Rockingham	UTM: Z 19 /E 330300 /N 4752775
SURVEY NUMBER: 82		USGS QUAD: Haverhill Quad 15' series
COMMON NAME: The Patten House		FUNCTIONAL TYPE: Farmhouse
HISTORIC NAME: R. K. Davis House		PRESENT USE: Residence
LOCATION: S. Side Danville Rd., .05 Mi. E. Intersection of Rt. 111 42 Danville Rd.		ARCHITECT/BUILDER: Unknown
OWNER: Benjamin Patten		CONDITION: Exc. <u> </u> Good <u> </u> Fair <u>X</u> Poor <u> </u> Ruins <u> </u>
ADDRESS: Blueberry Cir. Hampstead, N.H.		INTEGRITY: Original Site <u> </u> X Moved <u> </u> (When: <u> </u>)
MAP & PARCEL #: R22-4		Major alterations & date: Unknown
DATE: C. 1860		
SOURCE: Inspection		
STYLE: Greek Revival		LEVEL/SIGNIFICANCE: Natl <u> </u> State <u> </u> Local <u>X</u>

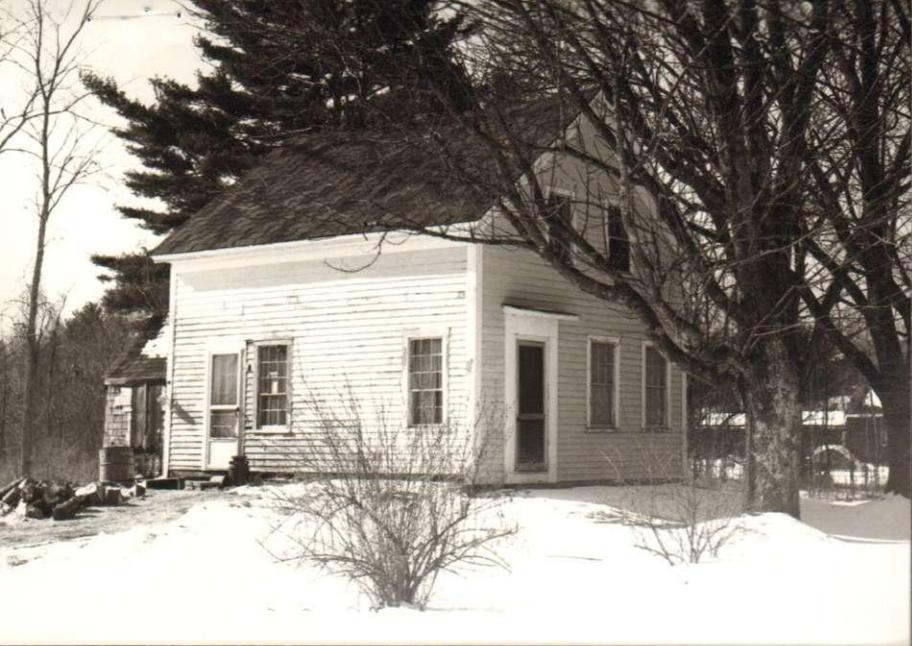
PHOTO

Description of View:

Front (N) Side (E)

The Patten house is a $1\frac{1}{2}$ story, gable roofed structure built in the mid-nineteenth century with Greek Revival characteristics evident in the gable front orientation toward the street and sidehall entry. The entrance has a 4 panelled door with a wide transom capped by a slightly projecting hood. All of the windows have nine over six and six over six sash. The medium pitched roof is topped by a narrow corbel capped chimney and the eave treatment consists of a boxed cornice with a wide frieze. The structure rests on a brick and stone foundation.

The 1 story, gable roofed ell has clapboard siding (same wood shingles on east elevation), six over six windows, and a 4 panelled door. It rests on columns and the roof is topped by a narrow, corbel capped chimney.
