HISTORIC PRESERVATION ASSISTANCE PROJECT Strafford Rockingham Regional Council

TOWN: Kingston	COUNTY: Rockingham
SURVEY NUMBER:	4 *
COMMON NAME:	Speliotis House
HISTORIC NAME:	
	side of Main Street .10 mile r. of W. Main St. & Main St.
OWNER: Peter N. Speliotis ADDRESS: 125 Main Street	
MAP & PARCEL #: U-8/14	
DATE: c. 1850	
SOURCE: Inspection	
STYLE: Greek Revival

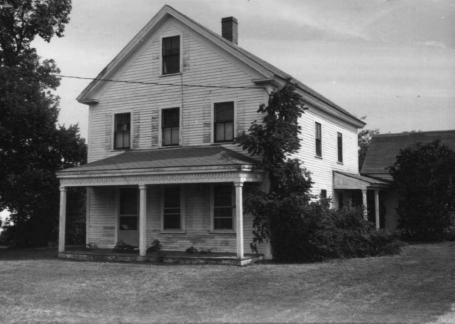
РНОТО

Description of View: Front-west

Side-south

RELATED STRUCTURES AND CONTEXT: On the east elevation of the main block is an attached 1-story shed. A separate 1%-story, gable-roofed barn is located to the southeast. It has clapboard siding and rests on a stone foundation. An attached shed projects from its east elevation. Two more sheds are located to the east of the barn.

A typical vernacular Greek Revival house in reasonably good repair and still in its original setting. Buildings of this period reflect the continued growth of Kingston in the 19th century.

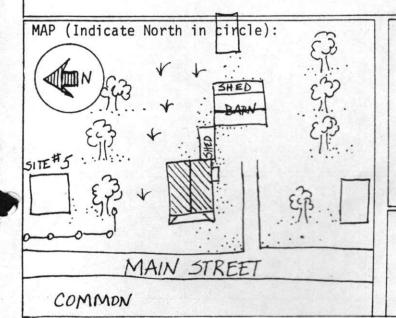
The Clark House is a 2½-story, Greek Revival style house which was remodeled during the Victorian era. The sidehall entry has a 4-panelled door with one large light shelt-ered by a hip-roofed veranda, on the gable end facade, with a denticulated frieze and supported by square posts. All of the windows have two-over-two sash. The medium-pitch roof is topped by a narrow, corbel-capped chimney and the eaves treatment consists of a boxed cornice with a wide, molded frieze and cable-end returns. A shed-roofed porch supported by square posts has been added to the south elevation. The house rests on a brick foundation.
