HISTORIC PRESERVATION ASSISTANCE PROJECT  
 Strafford Rockingham Regional Council  
 1 Water Street, Exeter, New Hampshire  
 Phone: (603) 778-0885

TOWN: <u>Kingston</u> COUNTY: <u>Rockingham</u> SURVEY NUMBER: <u>76*</u> COMMON NAME: <u>French House</u> HISTORIC NAME: <u>Rogers House</u> LOCATION: <u>W. side of Church St., .11 miles S of intersection of Church &amp; Cottage</u> OWNER: <u>Robert French</u> ADDRESS: <u>16A Church St., Kingston, NH</u> MAP & PARCEL #: <u>U-10/7</u> DATE: <u>c. 1855</u> SOURCE: <u>Inspection</u> STYLE: <u>Greek Revival Cape</u>	UTM: <u>Z 19/E 332200 /N 4755850</u> USGS QUAD: <u>Haverhill Quad 15' Series</u> FUNCTIONAL TYPE: <u>Dwelling</u> PRESENT USE: <u>Residential</u> ARCHITECT/BUILDER: <u>Unknown</u> CONDITION: <u>Exc. Goody Fair Poor Ruins</u> INTEGRITY: <u>Original Site</u> <input checked="" type="checkbox"/> <u>Moved</u> (When: <u>1981</u> ) Major alterations & date: <u>Back part c.1800? front added c.1870; 2nd story shed dormer 1981.</u> LEVEL/SIGNIFICANCE: <u>Nat'l State Local</u> <input checked="" type="checkbox"/>

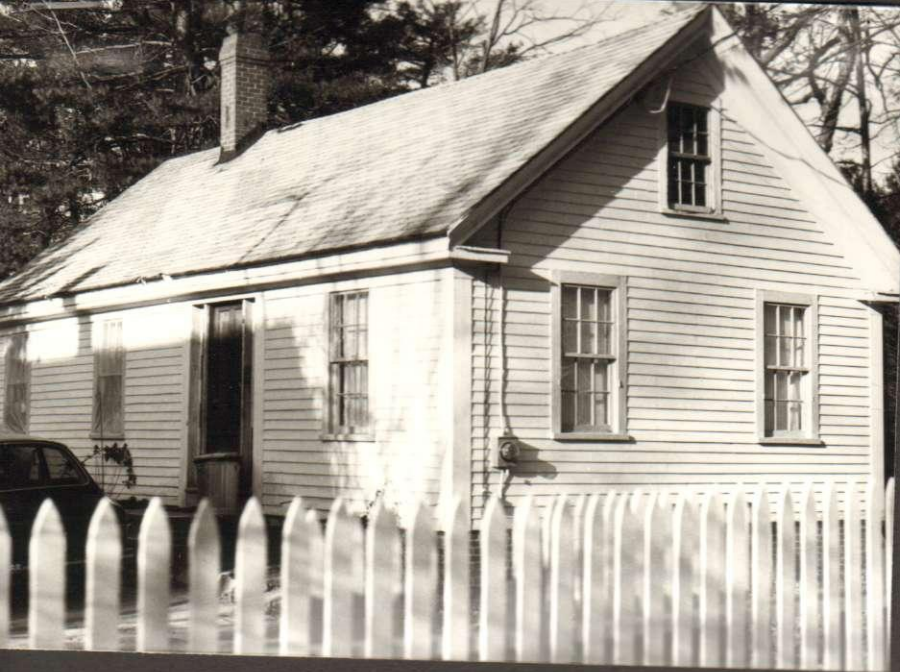
PHOTO

Description of View: Front-northeast  
Side-southeast

The French house is a 1½-story Cape built in the Greek Revival style. The offset entry has a 4-panelled door flanked by full-length sidelights. All of the windows have six-over-six sash. The medium-pitch roof is topped by two, tall, narrow, corbel-capped chimneys. The eaves treatment consists of a boxed cornice with gable-end returns. A small, six-over-six window is located in the gable. The house rests on a brick foundation. The 1-story, shed-roofed ell has clapboard siding and rests on stone.
