## HISTORIC PRESERVATION ASSISTANCE PROJECT

Strafford Rockingham Regional Council

TOWN: Kingston	COUNTY: Rockingham	UTM: Z 19 /E 332200 /N 4755650
SURVEY NUMBER: 84 *		USGS QUAD: Haverhill Quad 15' Series
COMMON NAME: First Congregational Church		FUNCTIONAL TYPE: Residential
HISTORIC NAME: Parsonage		PRESENT USE: Residential
LOCATION: West side of Church Street behind church		ARCHITECT/BUILDER: Unknown
OWNER: First Congregational Church		CONDITION: Exc. <input checked="" type="checkbox"/> Good <input type="checkbox"/> Fair <input type="checkbox"/> Poor <input type="checkbox"/> Ruins <input type="checkbox"/>
ADDRESS: 6 Church St. Kingston, NH.		INTEGRITY: Original Site <input checked="" type="checkbox"/> Moved <input type="checkbox"/> (When: <input type="text"/> )
MAP & PARCEL #: U-10, plot 12		Major alterations & date: 1968: Breezeway & garage
DATE: c. 1958		LEVEL/SIGNIFICANCE: Natl State Local
SOURCE: Assessor's Office, Kingston		
STYLE: Ranch

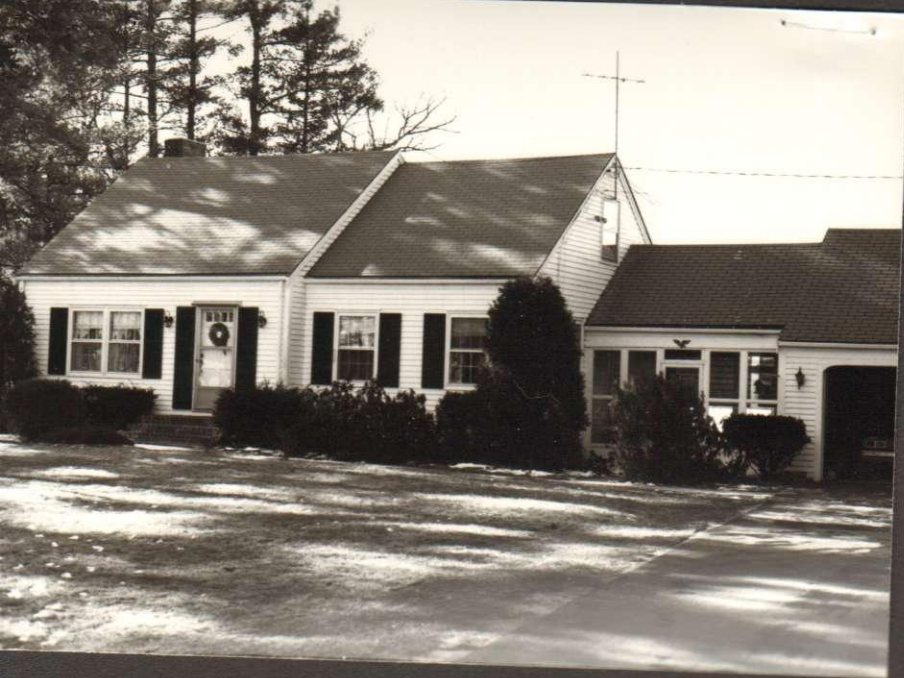
PHOTO

Description of View: Front-east  
Side-northPhotographer: Scott Novak  
Negative with: S.R.R.C.  
Negative File Number: K-80-70/7-7A

1½ story modern ½ cape with attached breezeway and garage.  
Main block has side entry flanked by shutters, 1 double bay.  
Addition has 2 bays  
8/8 windows with shutters  
Shed dormer on lake side  
Plain trim around doors, windows, eaves  
Foundation plantings typical feature.
