HISTORIC PRESERVATION ASSISTANCE PROJECT Strafford Rockingham Regional Council 1 Water Street, Exeter, New Hampshire

COUNTY: Rockingham TOWN: Kingston SURVEY NUMBER: District 2 COMMON NAME: The Swanson House HISTORIC NAME: Smith House LOCATION: SE side of Little River Road .15 mi NE of intersection w/Alma Ave. OWNER: Emil & Faith L. Swanson ADDRESS: 45 Little River Rd., Kingston, NH MAP & PARCEL #: R39-41 DATE: C. 1870 SOURCE: Inspection STYLE: Italianate

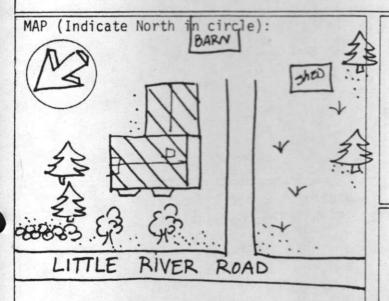
PHOTO

Description of View: Front (NW) Side (SW)

The Swanson house is a $2\frac{1}{2}$ story Italianate style structure. The 4 panelled center entry door contains two lights and is sheltered by a flat-roofed doorhood supported by heavy scroll brackets. Two 1 story, flat roofed bay windows on the facade contain narrow four over four windows above recessed panels. They have a boxed cornice supported by heavy brackets. Other main block windows have six over six sash. The medium pitched roof is topped by two corbel capped windows, and the eaves treatment consists of a boxed cornice with a wide frieze and gable end returns.

A 1 story open hip-roofed porch on the southwest rests on a fieldstone foundation. A 1 story gable roofed ell rests on a fieldstone and concrete foundation. It has a 6 panelled door, clapboard siding, wood shingles in the gable end, and windows with six over six sash. It has an oriel window on the southwest elevation.
