## HISTORIC PRESERVATION ASSISTANCE PROJECT Strafford Rockingham Regional Council 1 Water Street, Exeter, New Hampshire

TOWN: Kingston COUNTY: Rockingham SURVEY NUMBER: 4 COMMON NAME: Riley House HISTORIC NAME: P. Hardy House LOCATION: E side of Rte. 125, .23 miles S of the inter. of Newton Junc. Rd. & Rt. 125 Walter & Constance Riley ADDRESS: 57 Rte. 125, Kingston, NH MAP & PARCEL #: R-4/1 DATE: c. 1880 SOURCE: Inspection STYLE: Late 19th Century

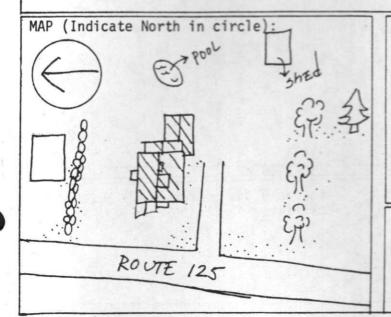
PHOTO

Description of View: Front-west Side-south

ADDITIONAL ARCHITECTURAL AND STRUCTURAL DESCRIPTION:  The Riley House is a 2%-story vernacular structure. The sidehall entry is located within a small, new 1-story open porch. It has a multi-panelled door with fan-shaped lights. The main block has various new windows, as well as two one-over-one windows which are located within a shed dormer on the south facade. The medium-pitched roof is topped by one end-placed chimney with a corbeled cap. Eaves treatment consists of a boxed cornice with gable end returns.  A 1-story, gable-roofed ell has two-over-two windows, a multi-panelled door with one large light, and a cement block foundation.
RELATED STRUCTURES AND CONTEXT:
BOUNDARY AND ACREAGE DESCRIPTION: 12 acres bounded to the N-Borin, S-Prenaveau, E-Gordon
W-Route 125.
REFERENCES:
1892 Map
STATEMENT OF SIGNIFICANCE (Evaluation & Historical Associations):
The Hardy House has been extensively altered, compromising its historic character.
