## HISTORIC PRESERVATION ASSISTANCE PROJECT Strafford Rockingham Regional Council 1 Water Street, Exeter, New Hampshire Phone: (603) 778-0885

TOWN: Kingston COUNTY:Rockingham	UTM: Z 19/E 329575 /N 4752125
SURVEY NUMBER: 40	USGS QUAD: Haverhill Quad 15' Series
COMMON NAME: Senter House	FUNCTIONAL TYPE: Residential
HISTORIC NAME: G. W. Silloway House	PRESENT USE: Residential
LOCATION: West side of Mill Rd., .27 miles	ARCHITECT/BUILDER: Unknown
S of the inter. of Rte. 111 & Mill Road. OWNER: Charles Senter	CONDITION: Exc. Good X Fair Poor Ruins
ADDRESS: 54 Mill Road Kingston, NH.	INTEGRITY: Original Site X Moved
	(When: )
MAP & PARCEL #: R-22/22 DATE: C. 1850	Major alterations & date:
	Tajor diceracións à date.
SOURCE: Inspection	LEVEL (SIGNIEICANCE: Nati State Local V
STYLE: Vernacular	LEVEL/SIGNIFICANCE: Natl_State_Local X

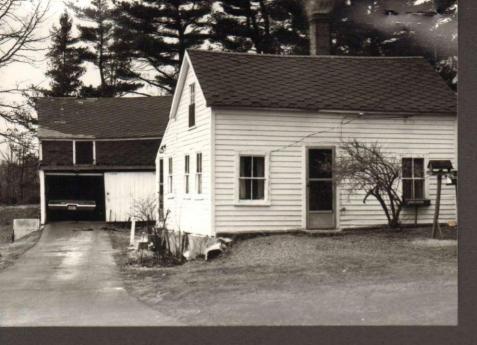
The Senter House is a 1%-story vernacular structure. The center entry door has four panels and one large light. Windows are two-over-two, except in the gables, which have six-over-two windows. The medium-pitched roof is topped by a corbel-capped chimney, and the eaves treatment consists of a boxed cornice.

A 1-story, shed-roofed ell has clapboard and wood shingle siding, two-over-two windows, and a 4-panelled door with one large light.
