HISTORIC PRESERVATION ASSISTANCE PROJECT Strafford Rockingham Regional Council 1 Water Street, Exeter, New Hampshire Phone: (603) 778-0885

TOWN: Kingston COUNTY: Rockingham	UTM: Z 19/E 329650 /N 4752100
SURVEY NUMBER: 41	USGS QUAD: Haverhill Quad 15' Series
COMMON NAME: Lessard House	FUNCTIONAL TYPE: Residential
HISTORIC NAME: H. R. Downing House	DESCENT HOS
LOCATION: East side of Mill Road, .31 miles	REDICERCIAL
S of the inter. of Rte. 111 & Mill Road.	ARCHITECT/BUILDER: Unknown
OWNER: Brian & Marie Lessard	CONDITION: Exc. Good XFair Poor Ruins
ADDRESS: 49 Mill Road Kingston, NH.	INTEGRITY: Original Site X Moved (When:)
MAP & PARCEL #: R-12/5	
DATE: c. 1850	Major alterations & date:
SOURCE: Inspection	Modified in c.1930
STYLE: Greek Revival	LEVEL/SIGNIFICANCE: Natl_State_Localx_
GENERAL DESCRIPTION: Structural System	
<pre>1. FOUNDATION: Stone X Brick Concrete Concrete Block 2. WALL STRUCTURE: Wood Frame Post & Beam Ballon Frame X Other Load Bearing Masonry Stone Brick Concrete Block Other Metal Iron Steel Other Other Other</pre>	
 WALL COVERING: Clapboard X Wood Shingle Novelty Stucco Stone Brick She Asphalt Sheeting Composite Board 0 ROOF SHEATHING: Wood Shingle Apshalt Sh Pres

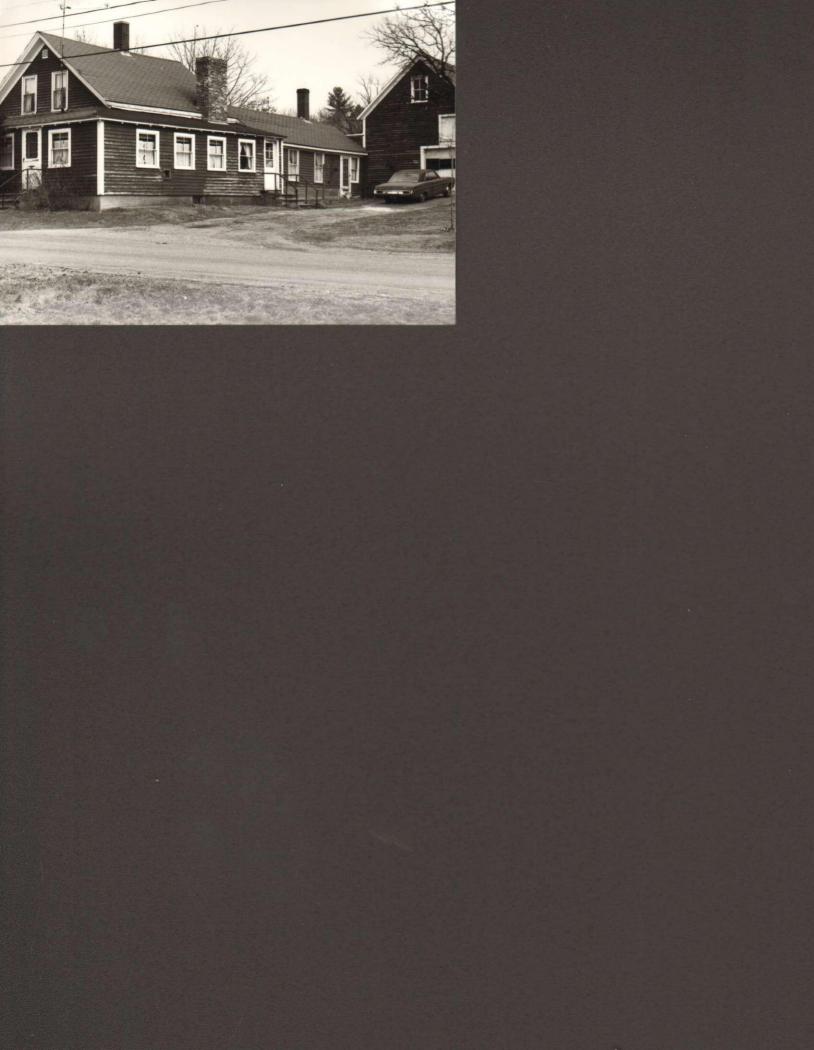
* * *	Description of View: Front-east
Mill Road	Side-north
+ + + + + + + + + + + + + + + + + + +	Photographer: Herb Bubert Negative with: S.R.R.C. Negative File Number: K-80-8c/10-10A

The Lessard House is a 1½-story vernacular structure built around the turn of the century. The entry door is sheltered by a 1-story, shed-roofed enclosed porch that extends along the north and east facades. The porch sits on a concrete block foundation, has clapboard siding, two-over-one windows, and two identical door; each with two panels and three lights.

The main block has a medium-pitched roof topped by a narrow chimney, and the eaves treatment is a boxed cornice. Windows are two-over-two.

A large, 1-story, gable-roofed elll has the same siding, eaves, and windows as the main block, and is topped by a tall corbel-capped stove chimney.

Another 1-story ell has a shed roof with exposed rafters, and rests on a concrete foundation.

RELATED STRUCTURES AND CONTEXT: An attached 11/2-story, gable-roofed barn has clapboard siding, two-over-two windows, a modern garage door, and a vertical-board hayloft door.
