HISTORIC PRESERVATION ASSISTANCE PROJECT Strafford Rockingham Regional Council 1 Water Street, Exeter, New Hampshire

TOWN: COUNTY: Rockingham Kingston SURVEY NUMBER: 85 COMMON NAME: Battles House HISTORIC NAME: C. Davis House LOCATION: West side of Main St., .02 miles North of the intersection of Rte. 125. Wendell Battles heirs ADDRESS: 4B Main St., Kingston, NH MAP & PARCEL #: R-21/23 DATE: c. 1790 SOURCE: Inspection STYLE: Federal Cape

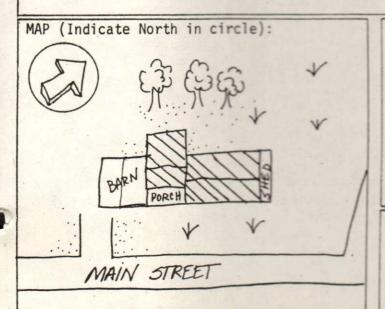
PHOTO

Description of View: Front-east Side-south

The Battles House is a 1½-story Federal Cape style structure. The center entry. has a new 4-panel door with one large light. All windows are two-over-two. Cornice treatment consists of close raking eaves and boxed, molded, lateral eaves. The medium-pitched roof is topped by two end-placed chimneys.

A 1-story shed-roofed shed along the north elevation has clapboard siding, twoover-two windows, and close eaves.

A 1½-story gable-roofed wing has the same siding, windows, cornice treatment, and foundation as the main block. It has an attached 1-story shed-roofed open porch on a cement foundation.
