HISTORIC PRESERVATION ASSISTANCE PROJECT Strafford Rockingham Regional Council 1 Water Street, Exeter, New Hampshire

TOWN: Kingston COUNTY: Rockingham SURVEY NUMBER: 88 COMMON NAME: The Tucker House HISTORIC NAME: Unknown LOCATION: W. side Main St. across from inter_ARCHITECT/BUILDER: Unknown section of New Boston Road OWNER: Annie Tucker ADDRESS: 80A Main St., Kingston, NH MAP & PARCEL #: U6-42 DATE: c.1920-1925 (Christie & Bakie) SOURCE: Inspection Square House STYLE:

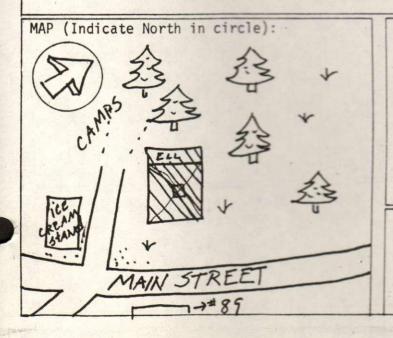
РНОТО

Description of View: Front (S) Side (E)

The Tucker house is a 2 story Square House structure. It has a low-pitched pyramidal hip-roof topped by a central chimney. Wall covering is clapboard on the first story and wood shingle on the second story. The two matching entry doors are both multi-panelled and multi-lit.

All windows are two over one. Eaves treatment consists of a boxed cornice with a sloped soffit.

A 2 story shed roofed ell rests on a cement foundation. It has the same siding as the main block, projecting eaves with exposed rafters, and one exterior chimney.
