HISTORIC PRESERVATION ASSISTANCE PROJECT

Strafford Rockingham Regional Council

TOWN: Kingston	COUNTY: Rockingham	UTM: Z 19/E 333350 /N 4754975
SURVEY NUMBER: 105		USGS QUAD: Haverhill Quad 15' Series
COMMON NAME: Champion House		FUNCTIONAL TYPE: Farmhouse
HISTORIC NAME: J. Schelling House		PRESENT USE: Residential
LOCATION: N side of Depot Rd., .11 miles E of intersection of Rte. 107A.		ARCHITECT/BUILDER: Unknown
OWNER: Dorothy Champion		CONDITION: Exc. <u>Good</u> X Fair Poor Ruins
ADDRESS: 46 Depot Rd., Kingston, NH		INTEGRITY: Original Site <u>X</u> Moved (When:)
MAP & PARCEL #: R-29/8		Major alterations & date: unknown
DATE: c. 1780		
SOURCE: Inspection		
STYLE: Georgian/Federal		LEVEL/SIGNIFICANCE: Natl State Local <u>X</u>

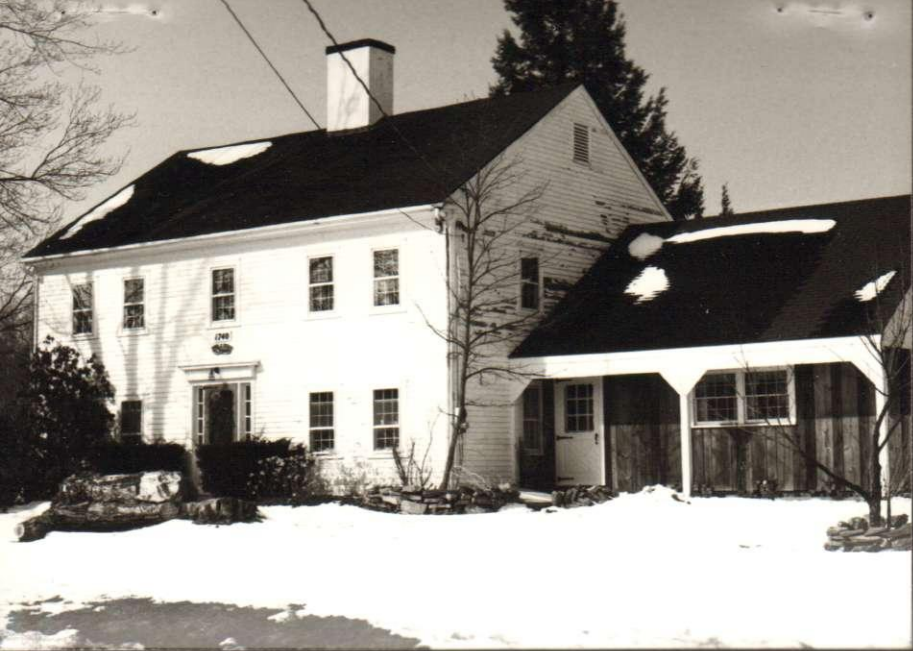
PHOTO

Description of View: Front-south
Side-east

The Champion House is a 2½-story transitional Georgian/Federal style structure. The 4-panelled center entry door is flanked by half-length sidelights above recessed panels. The door is surmounted by a denticulated entablature. Windows have nine-over-six sash on the first story and six-over-six sash on the second story. Cornice treatment consists of close raking eaves and boxed lateral eaves.

A 1½-story wing on the east elevation rests on a cement foundation. It has clapboard, vertical-board, and cement block siding. It has fixed light windows, and a multi-light door. The projecting roof on the front facade forms an open porch.
