HISTORIC PRESERVATION ASSISTANCE PROJECT Strafford Rockingham Regional Council 1 Water Street, Exeter, New Hampshire

TOWN: Kingston	COUNTY: Rockingham
SURVEY NUMBER:	124
COMMON NAME:	Cross House
HISTORIC NAME:	H. D. Webster House
LOCATION: W sid	de of Church St., across the e inter. of Cottage St.
Anness. 2	ary Cross 4 Church Street ingston, NH-
MAP & PARCEL #: R-30/5	
DATE: c. 1860	
SOURCE: Inspe	ection
STYLE: Greek	c Revival
CENEDAL DESCRIPTION: Structural System

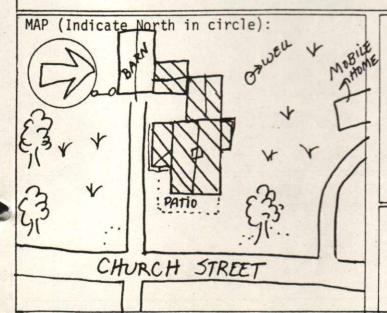
РНОТО

Description of View: F1 nt-east

Side-south

The Cross House is a 1½-story Greek Revival style structure featuring gable front orientation to the street. The 2-panalled sidehall entry door contains two vertical lights with segmentally arched heads, and is surmounted by a partial entablature. Windows have two-over-two sash, and are flanked by shutters and surmounted by slightly projecting caps. The medium-pitched roof is surmounted by one chimney, and the treatment at the eaves consists of a boxed cornice with gable end returns.

An enclosed 1-story shed-roofed porch on the south elevation has windows with twoover-two sash and recessed ponds below.

A 1-story, flat-roofed wing on the north elevation has the same siding, windows, foundation, and eaves treatment as the main block.

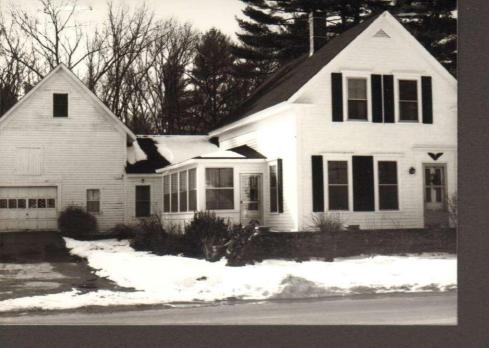
A 1-story, gable-roofed ellerests on a brick foundation. It has clapboard siding, assorted new windows, and a boxed cornice.

A 1-story, gable-roofed wing is attached to the ell. It has clapboard siding, a boxed cornice, and two-over-two windows. It rests on a brick foundation.

RELATED STRUCTURES AND CONTEXT: An attached 2-story, gable-roofed barn rests on a brick foundation. It has clapboard siding, projecting eaves, two-over-two windows, a vertical-board hayloft door, and a new garage door.
