HISTORIC PRESERVATION ASSISTANCE PROJECT

Strafford Rockingham Regional Council

TOWN: Kingston	COUNTY: Rockingham	UTM: Z 19/E 329200 /N 4756225
SURVEY NUMBER: 127		USGS QUAD: Haverhill Quad 15' series
COMMON NAME: The Gottwald House		FUNCTIONAL TYPE: Residential
HISTORIC NAME: Unknown		PRESENT USE: Residence
LOCATION: NE side N. Danville Rd., 2.01 Mi. W. of intersection of Church Street		ARCHITECT/BUILDER: Unknown
OWNER: Arthur Gottwald & Natalie Somers		CONDITION: Exc. <input checked="" type="checkbox"/> Good <input checked="" type="checkbox"/> Fair <input type="checkbox"/> Poor <input type="checkbox"/> Ruins
ADDRESS: 41 Blossom St., Arlington, Mass		INTEGRITY: Original Site <input checked="" type="checkbox"/> Moved <input type="checkbox"/> (When:)
MAP & PARCEL #: R32-3		Major alterations & date:
DATE: C. 1900		Addition in 1960
SOURCE: Inspection		LEVEL/SIGNIFICANCE: Natl State Local <input checked="" type="checkbox"/>
STYLE: Early 20th Century Vernacular

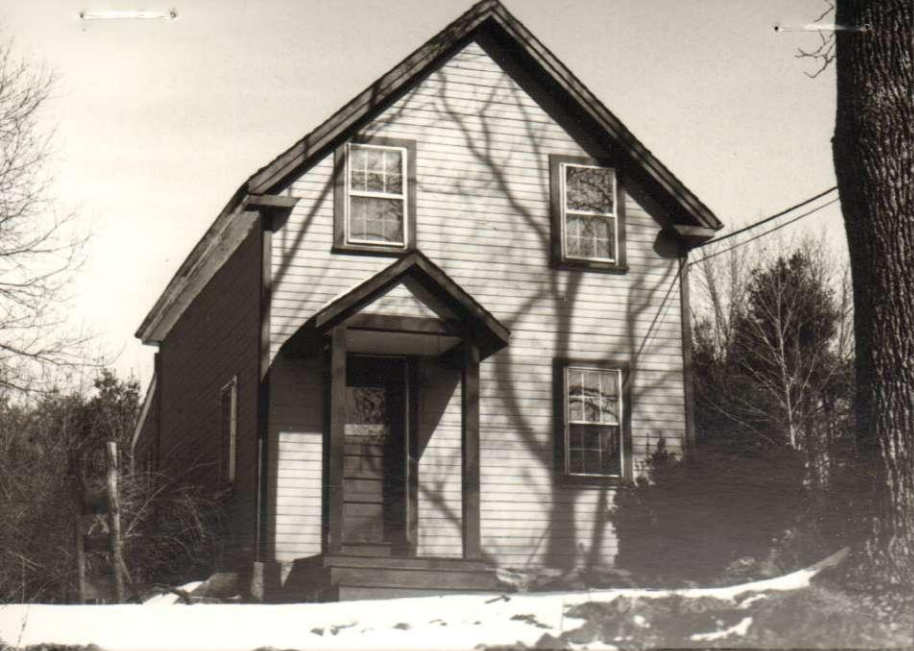
Negative File Number: K80-10C-26A-27

Front (SW) Side (NW)

The Gottwald house is a 1½ story, gable roofed vernacular house built around the turn of the century. The sidehall entry has a 4 panelled door with one large light sheltered by a 1 story, gable roofed, open porch supported by square posts. All of the windows have six over six sash. The medium pitch roof is topped by an exterior chimney on its north-east elevation and the eaves treatment consists of a boxed cornice with gable end returns. The house rests on a cement foundation.

The 1 story, shed roofed ell has clapboard siding, a 3 panelled door with three lights, six over one windows, and rests on a cement foundation.
