HISTORIC PRESERVATION ASSISTANCE PROJECT
Strafford Rockingham Regional Council
1 Water Street, Exeter, New Hampshire
Phone: (603) 778-0885

<p>TOWN: <u>Kingston</u> COUNTY: <u>Rockingham</u></p> <p>SURVEY NUMBER: <u>129</u></p> <p>COMMON NAME: <u>The Emerson House</u></p> <p>HISTORIC NAME: <u>O. Bean House</u></p> <p>LOCATION: <u>N. side North Danville Rd.,</u> <u>1.87 Mi. W. intersection Church St.</u></p> <p>OWNER: <u>Dave Emerson</u></p> <p>ADDRESS: <u>85 N. Danville Rd., Kingston, NH</u></p> <p>MAP & PARCEL #: <u>R32-5</u></p> <p>DATE: <u>C. 1750</u></p> <p>SOURCE: <u>Inspection</u></p> <p>STYLE: <u>Georgian</u></p>	<p>UTM: <u>Z 19/E 329400 /N 4756200</u></p> <p>USGS QUAD: <u>Haverhill Quad 15' series</u></p> <p>FUNCTIONAL TYPE: <u>Farmhouse</u></p> <p>PRESENT USE: <u>Residential/Commercial</u></p> <p>ARCHITECT/BUILDER: <u>Unknown</u></p> <p>CONDITION: <u>Exc. xx Good Fair Poor Ruins</u></p> <p>INTEGRITY: Original Site <u>x</u> Moved <u> </u> (When: <u> </u>)</p> <p>Major alterations & date: <u>Unknown</u></p> <p>LEVEL/SIGNIFICANCE: Natl <u> </u> State <u> </u> Local <u>xx</u></p>

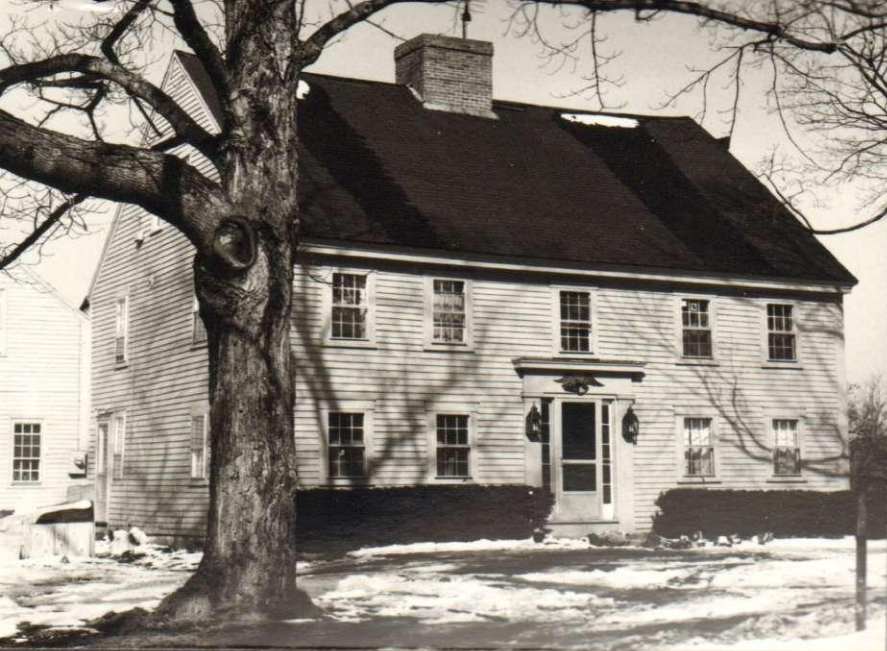
PHOTO

Front (S) Side (W)

The Emerson house is a 2 $\frac{1}{2}$ story, 5X2 bay, central chimney, Georgian style house. The center entry has a 4 panelled door framed by full length sidelights. Flanking the door are pilasters which rise to a full entablature. Most of the windows have slightly projecting caps and six over six, nine over six, or twelve over eight sash. The medium pitch roof is topped by a massive central chimney and the eaves treatment consists of a boxed cornice along the lateral eaves and close raking eaves with slight gable end returns. The house rests on a granite slab foundation.

The 1 $\frac{1}{2}$ story, gable roofed ell has clapboard siding, a 3 panelled door with four lights, and nine over six windows. Its steeply pitched roof is topped by a narrow chimney and the ell rests on a brick and stone foundation. Projecting from the west elevation of the ell is a 2 story, flat roofed wing.
